Legally Privileged Multidisciplinary Expert Report

McCrae Landslip Project

5 May 2025

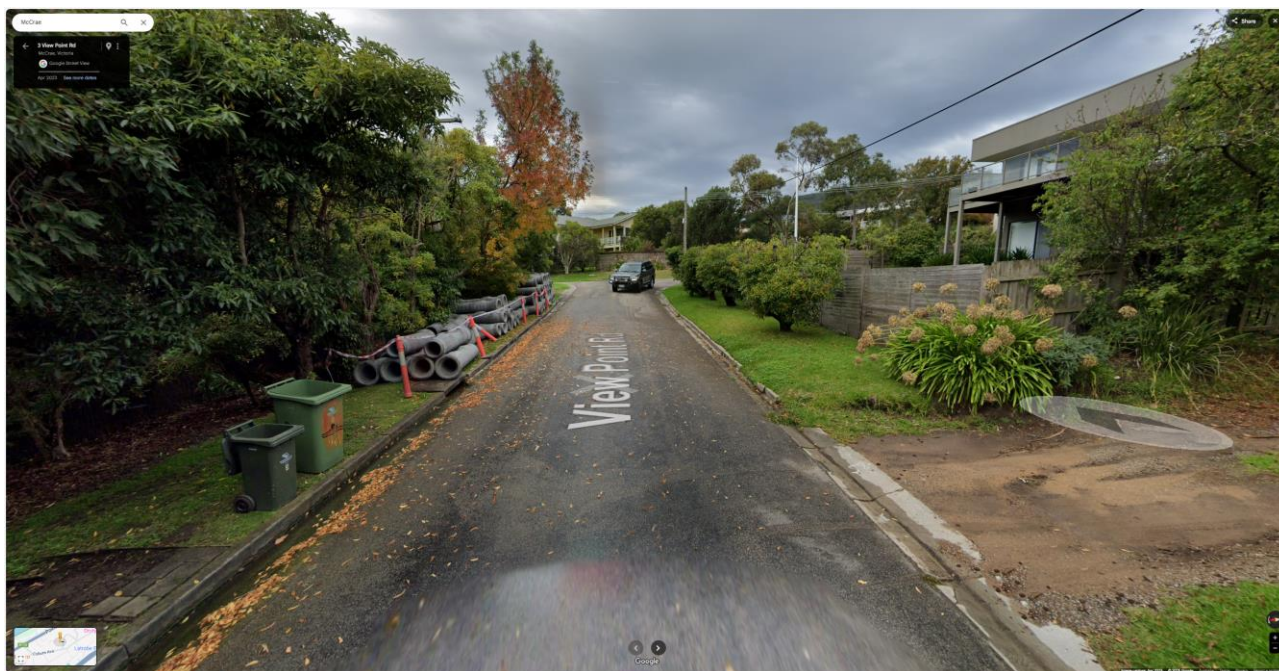
Figure 4: Google Streetview image from April 2023 looking east from outside No. 3 View Point Road. Note the stored pipes on the verge.

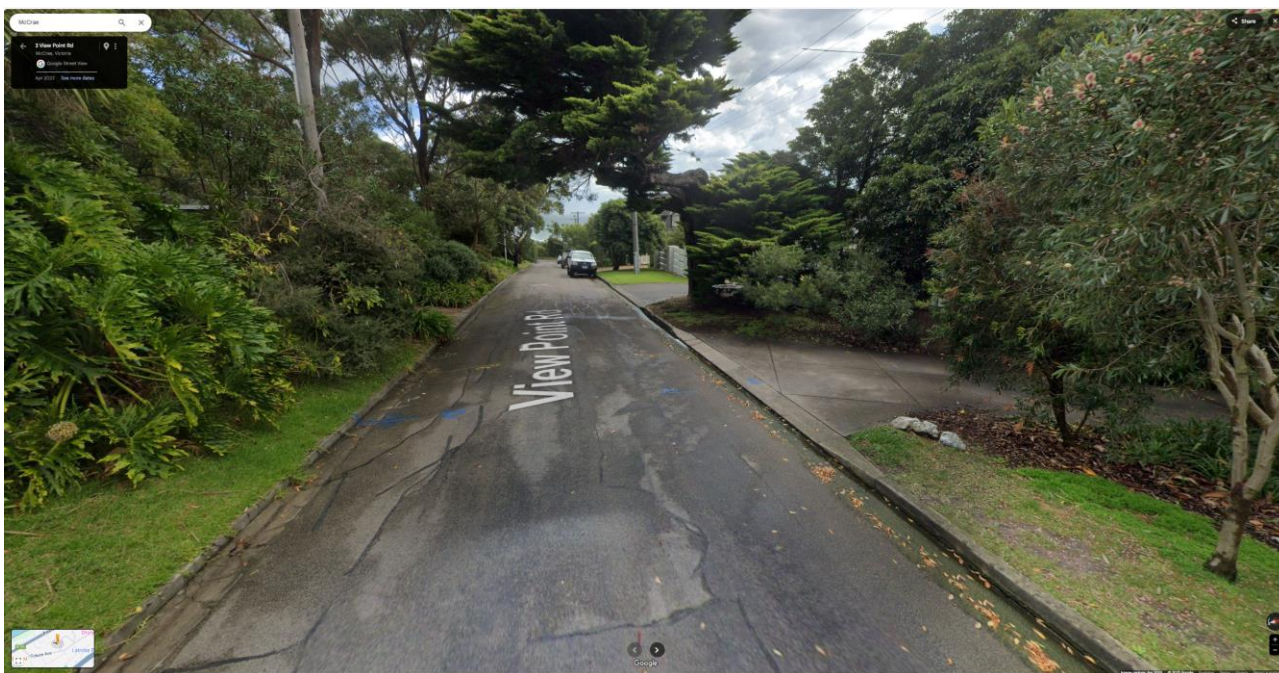
Figure 5: Google Streetview image from April 2023 looking west from outside No. 3 View Point Road.

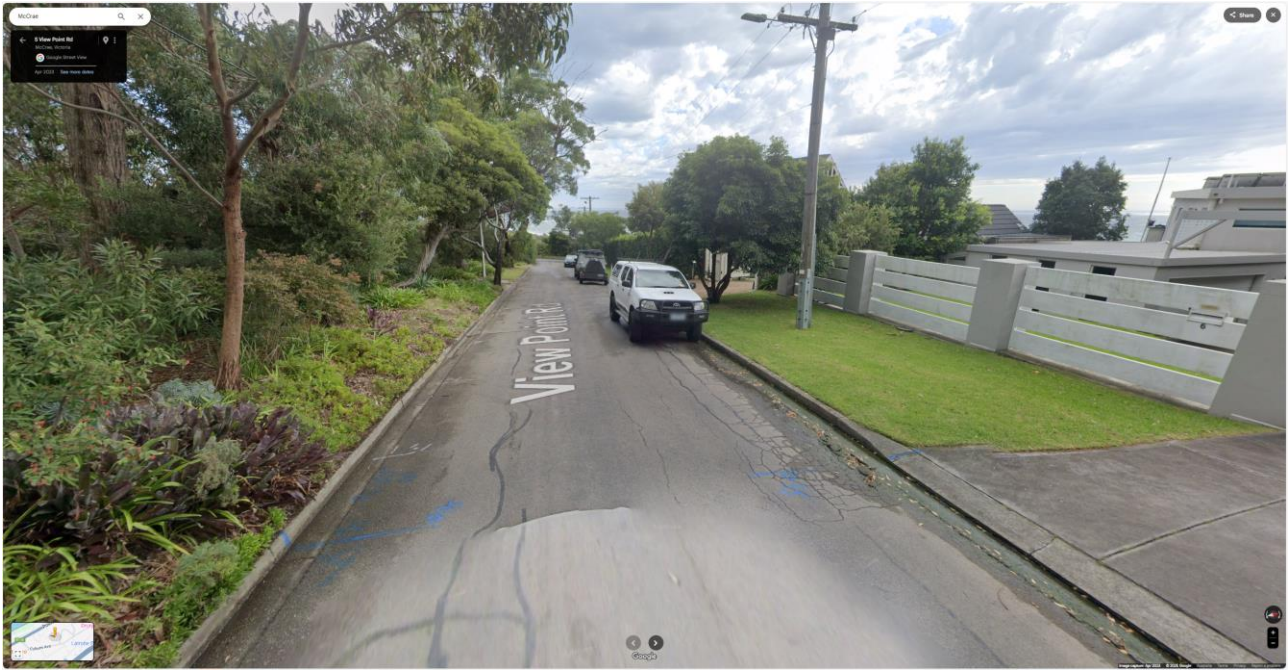
Figure 5, Figure 6 and Figure 7 provide an indication of the condition of View Point Road. The condition of the pavement is characterised by numerous longitudinal cracks (Figure 5) and areas of crocodile cracking and spalling. Such evidence can indicate pavement fatigue or aging, or weak subgrade. Water is noted to be flowing down the eastbound kerb within the photographs. The precise date of the photographs is not known. But we note the greenish tinge of the kerb and channel, compared to the south side, which could indicate vegetation build up due to high levels of moisture content.

Figure 6: Google Streetview image from April 2023 looking west from outside No. 6 View Point Road. Note the localised spalling and crocodile cracking of the pavement adjacent to the driveway of No. 6.

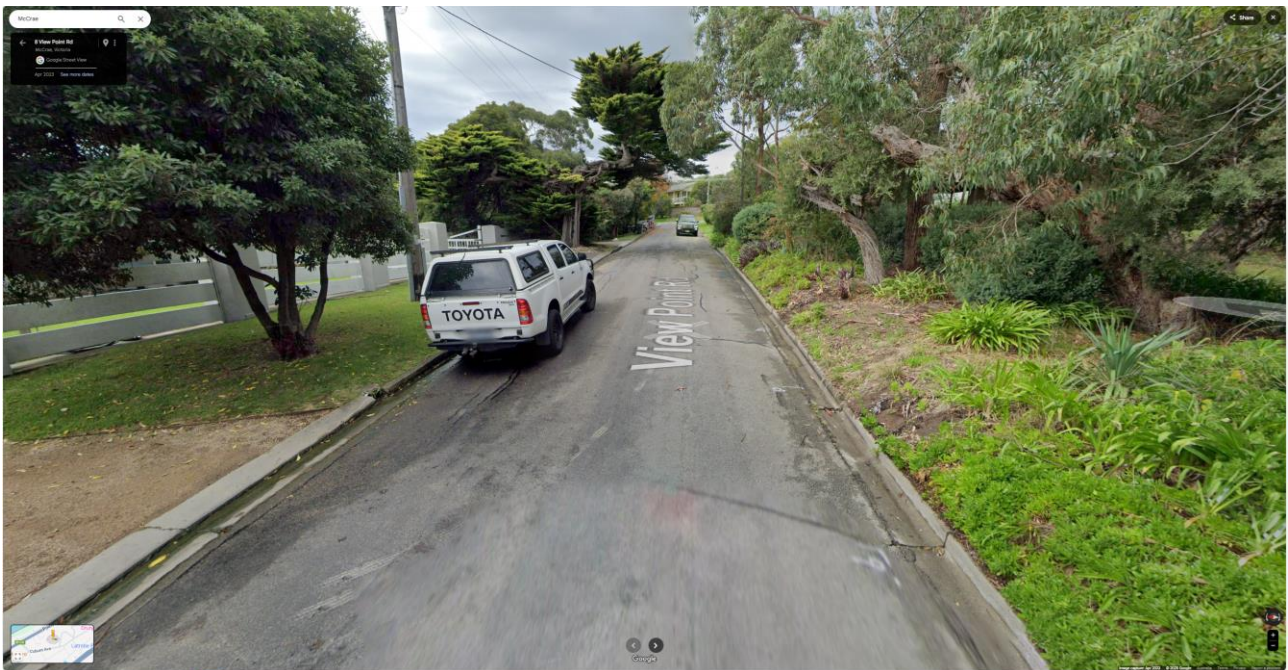
Figure 7: Google Streetview image from April 2023 looking east from outside No. 10-12 View Point Road.

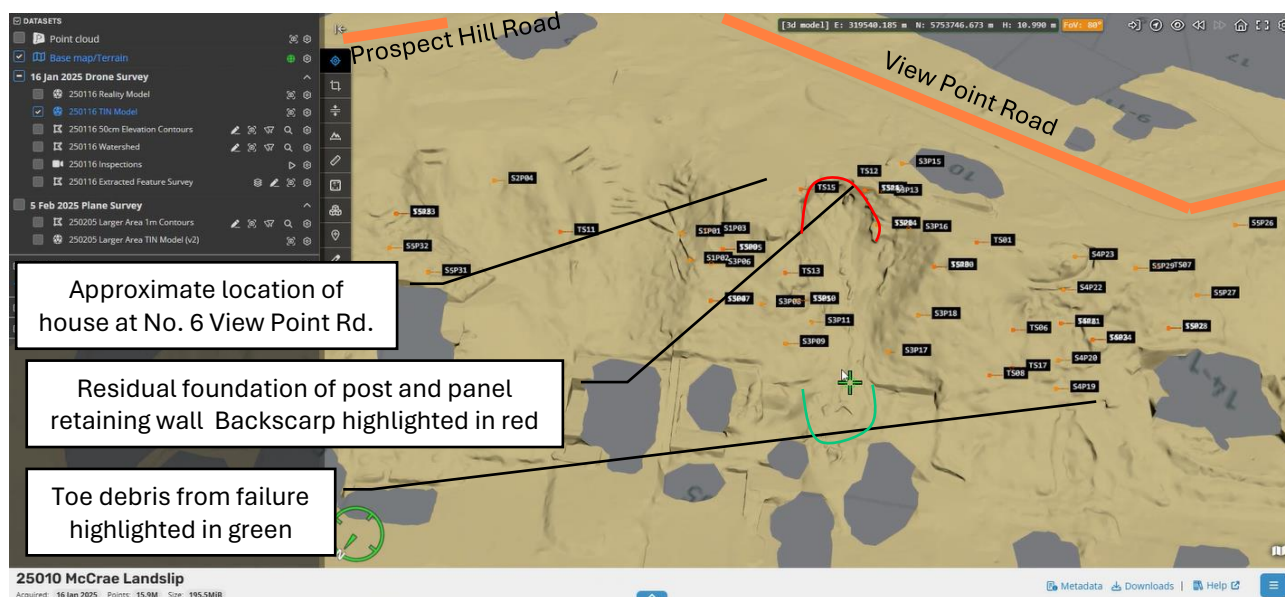
Figure 8: Imagery showing the subject site and adjacent slopes looking south west.

Figure 8 shows an overview of the site topography. The backscarp toe debris of the 14 January 2025 failure is highlighted. Note that the failure is within a clearly defined gully, which is a characteristic of the escarpment within the vicinity of the subject site.

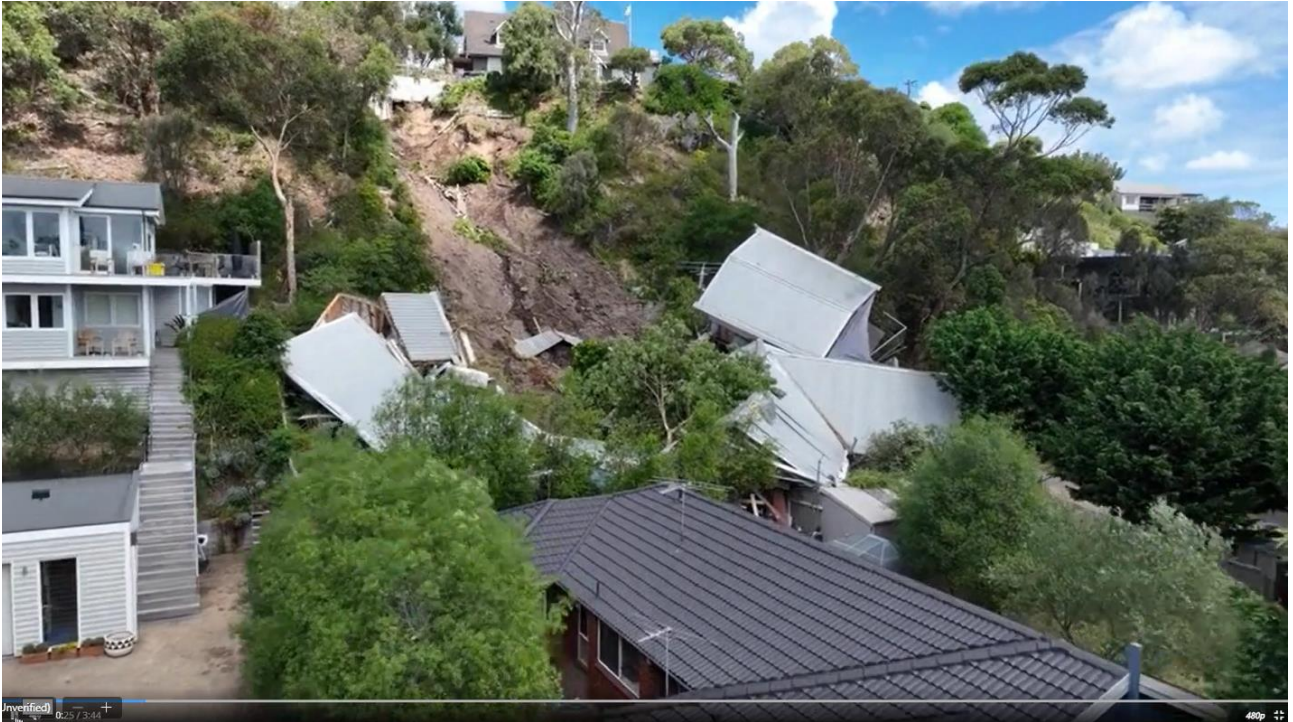
Figure 10: Drone footage taken from toe of slope failure showing the gully, denuded by slipping debris from upslope.

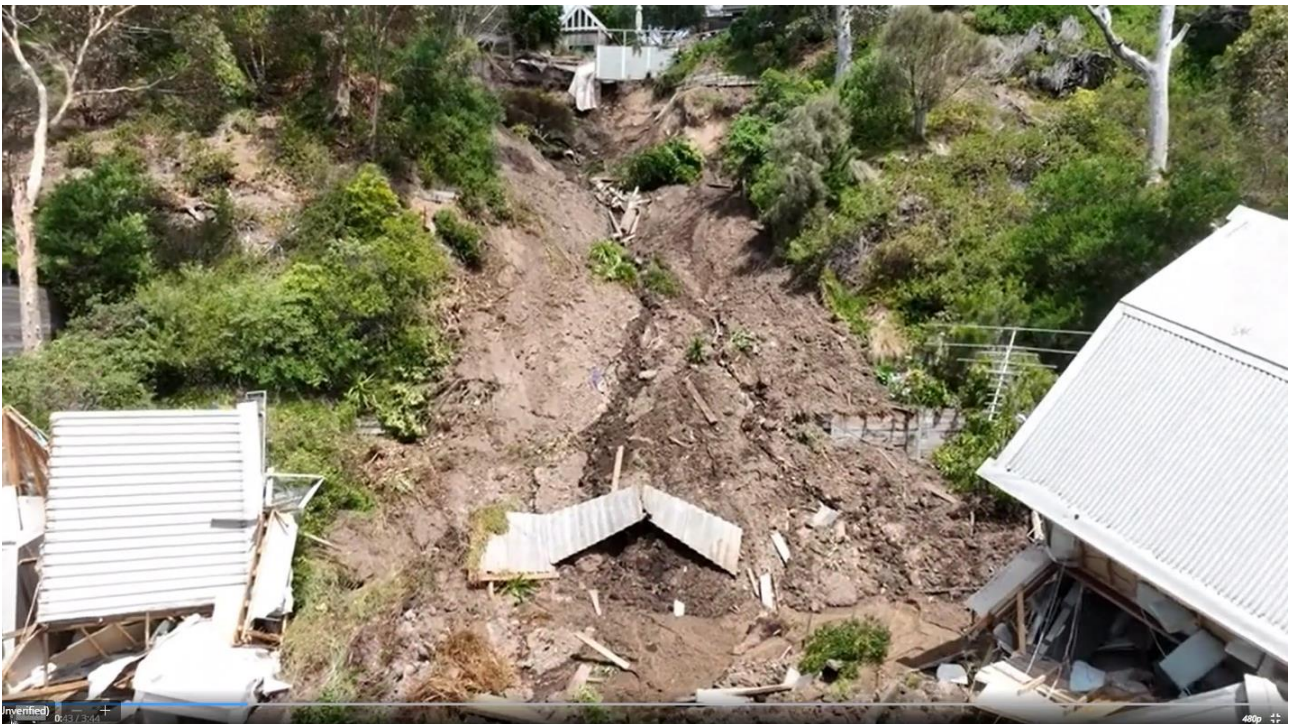
Figure 11: Drone footage taken from toe of failure, illustrating the 'bowl' shaped failure within the upper slope.

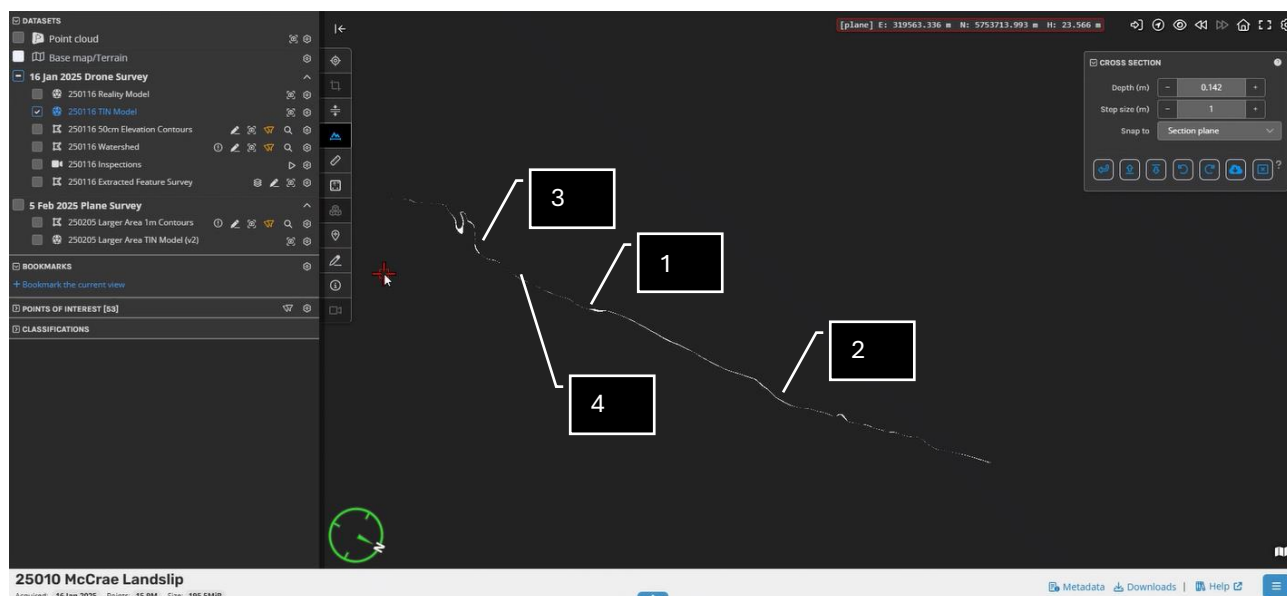
Figure 13: Cross section based on information from drone footage

Although Figure 13 is not scaled, the variation of the slope gradient is clear. Note that between points 1 and 2, the cross-section cuts through undisturbed slope. Point 3 shows the location of the backscarp of the failure, with point 4 the slip surface. The geometry of the topography shown in Figure 8, Figure 10 and Figure 11, suggest that the slip surface of the failure daylighted at an elevation similar to point 1. The toe debris has funnelled down a narrow gully throat before spilling out as illustrated in Figure 8 and Figure 11.

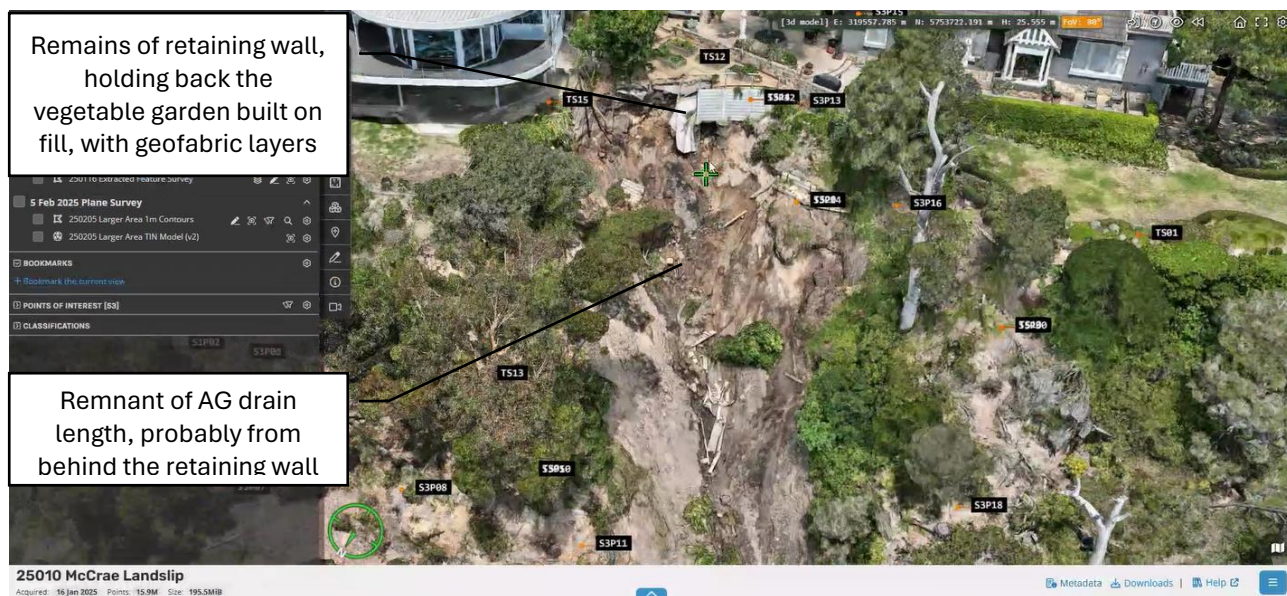
Figure 14: Drone footage showing detail of the failure.

Figure 14 shows the debris field of the failure. We note that a retaining wall at the crest of the site, and the retained platform behind, has been undermined by the slope movement, revealing geotextile layers. Fence panels are also seen in the debris. The varying colouration of the exposed soils suggest varying moisture content, and perhaps running water.

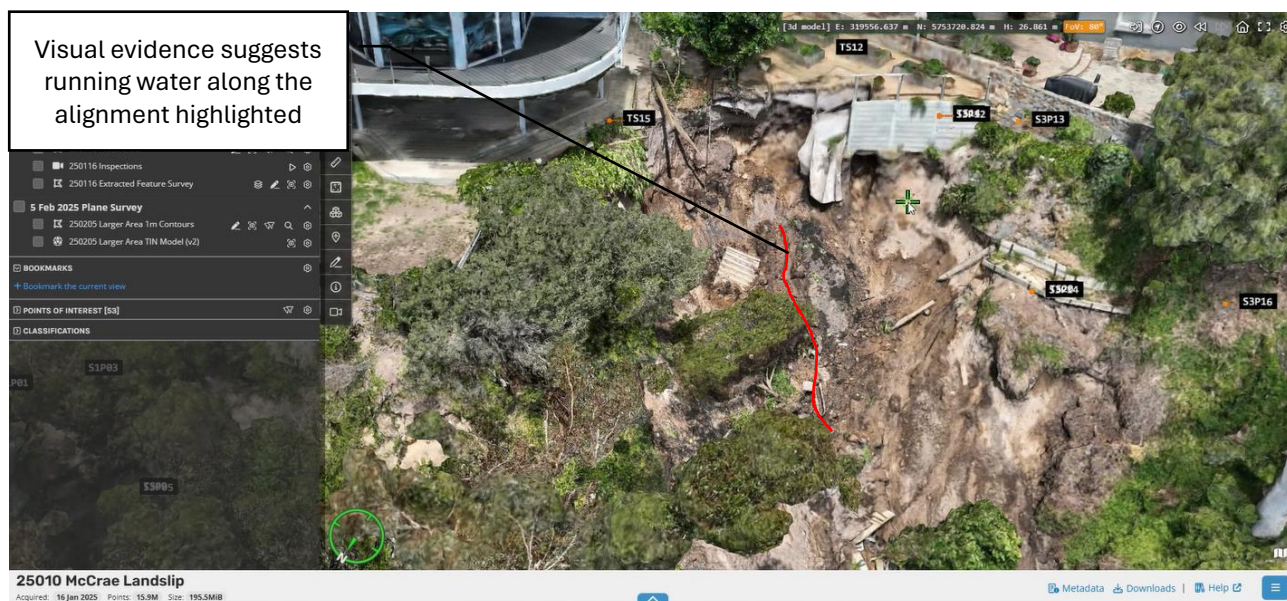
Figure 15: Detail of the presumed slip area with the red line an annotation of possible running water at the time of drone footage.

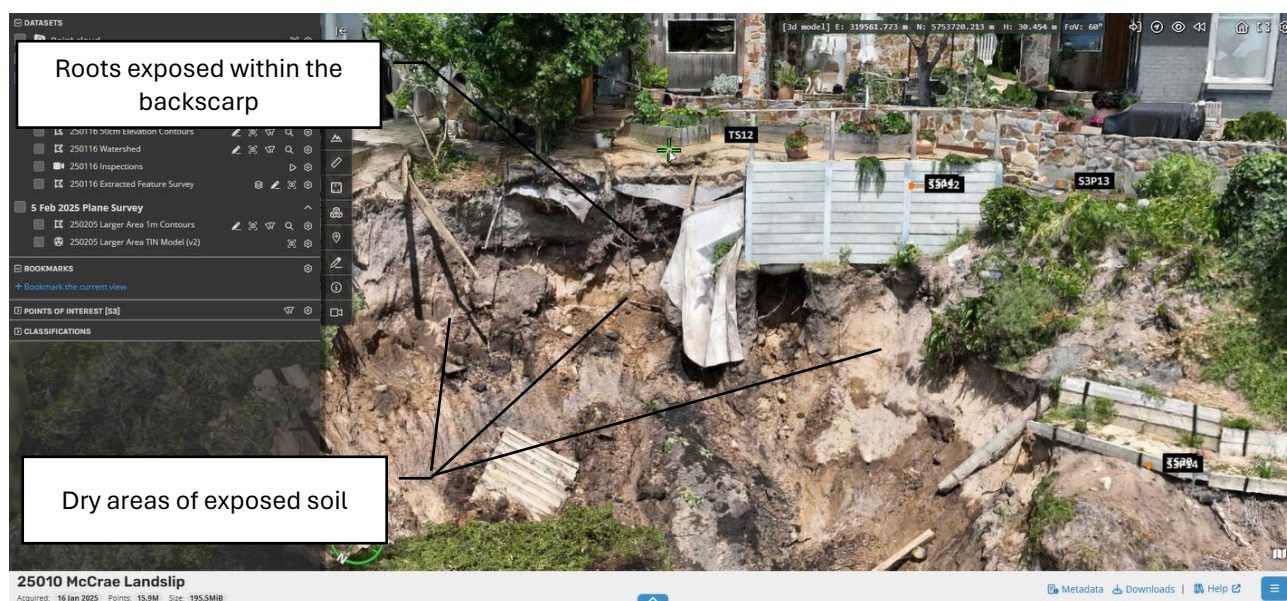
Figure 17: Drone footage looking directly at retaining wall

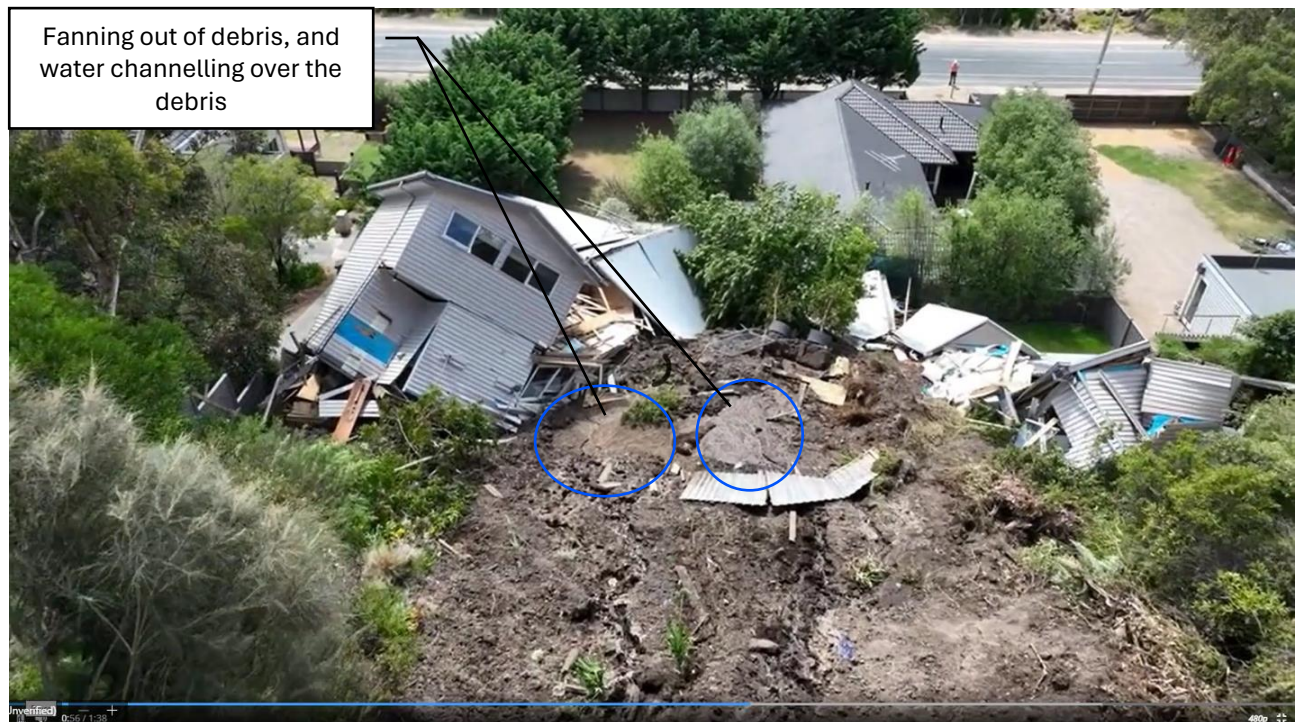
Figure 18: Drone footage, showing the toe debris.

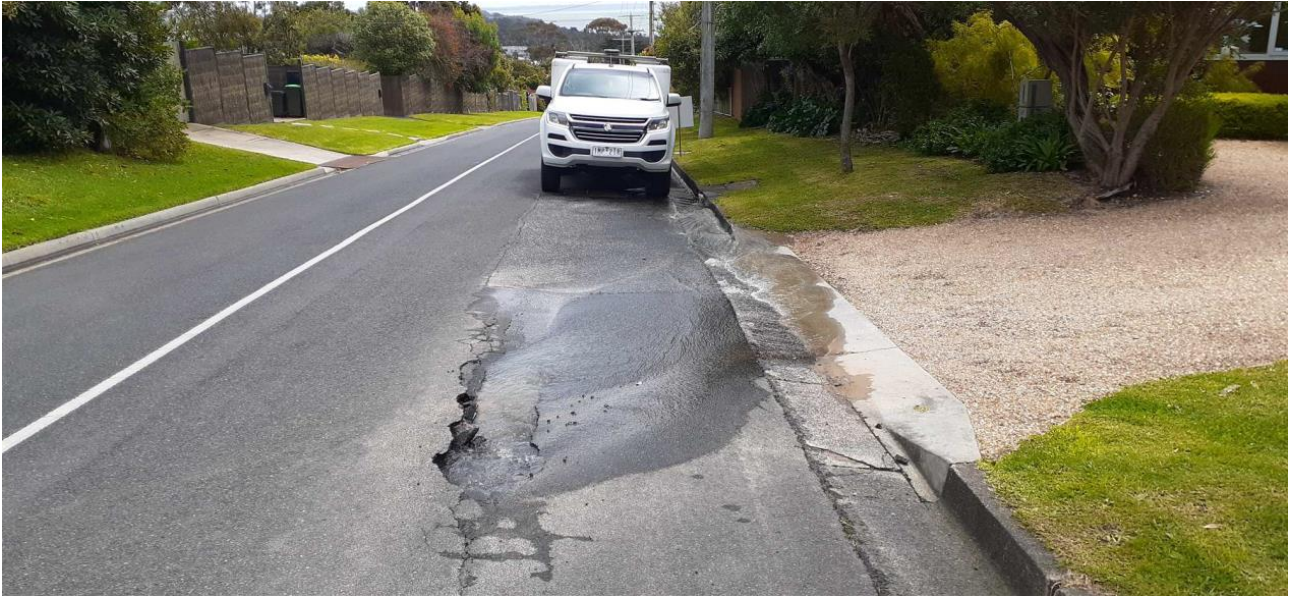
Figure 21: Photograph from SEW taken on 14 November 2022, looking west along Coburn Avenue from junction with Prospect Hill Road showing site conditions.

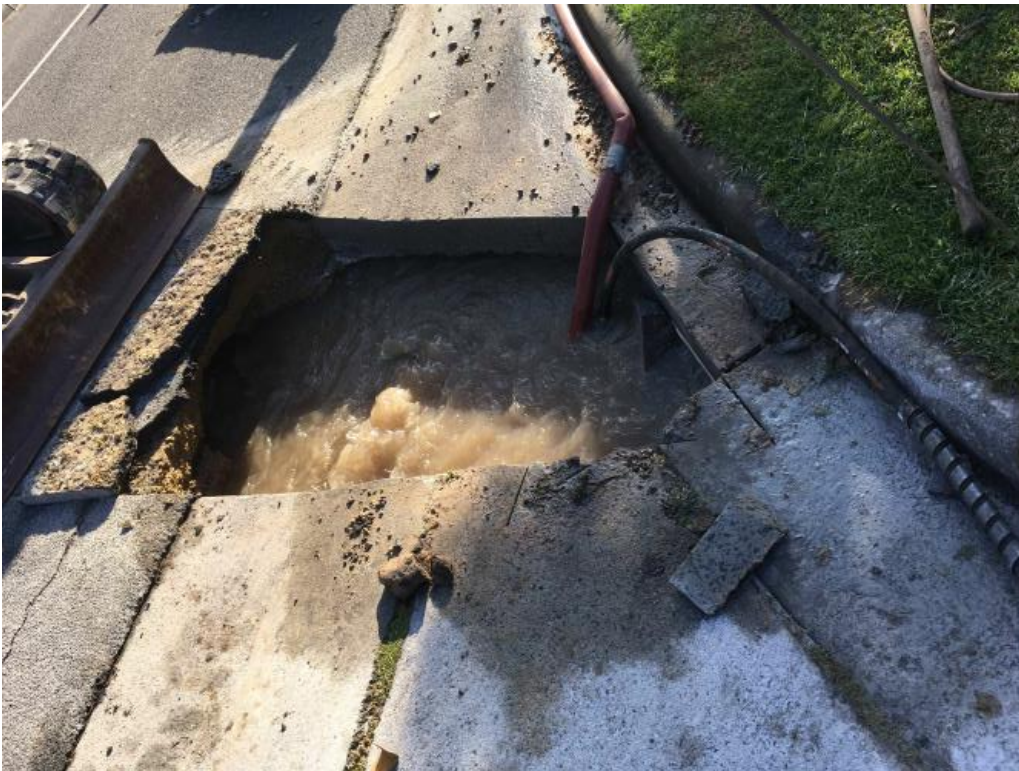
Figure 22: Photograph from SEW taken on 15 November 2022 (approximately), showing detail of water beneath concrete pavement construction prior to repair, being pumped out.

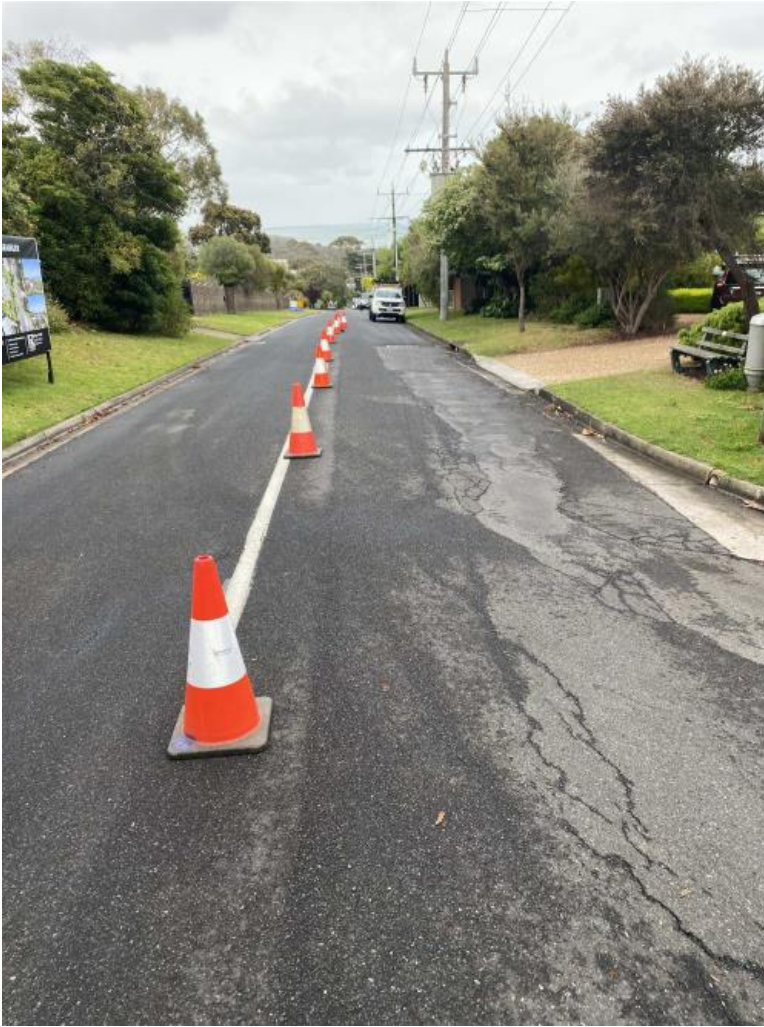
Figure 28: Photograph from SEW taken on 29 November 2023 (approximately), looking west along Coburn Avenue from junction with Prospect Hill Road showing condition of pavement prior to repair works.

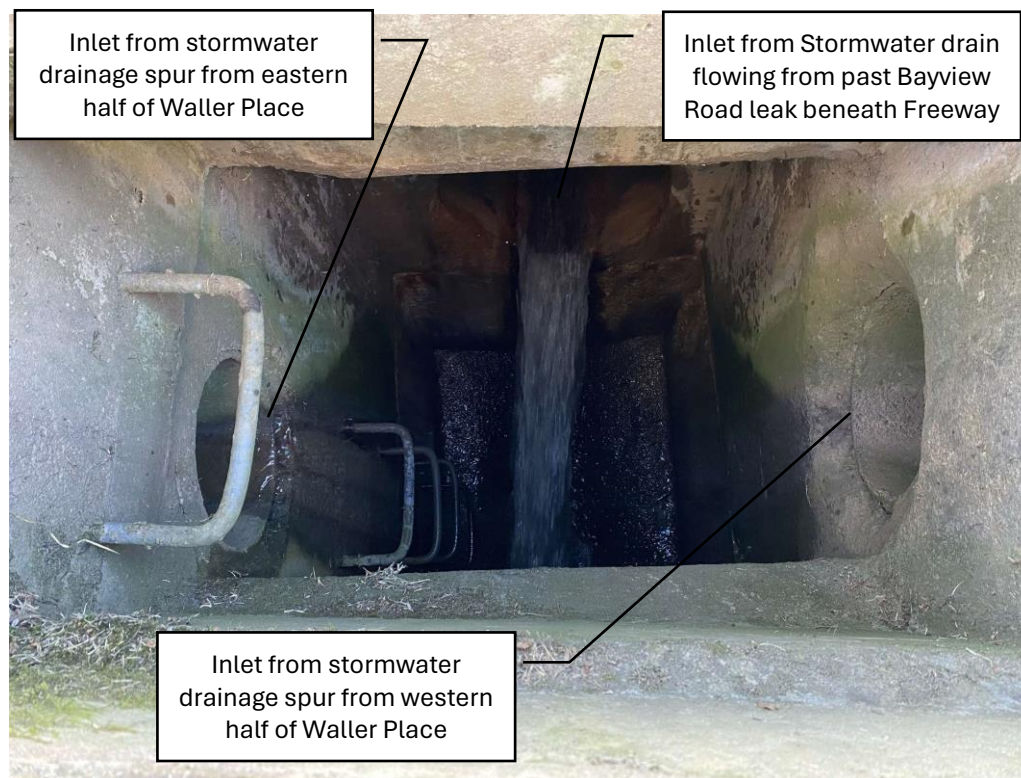
Figure 41: Photograph supplied by SEW, taken on 30 December 2024, showing water flowing into pit opposite 6 Waller Place

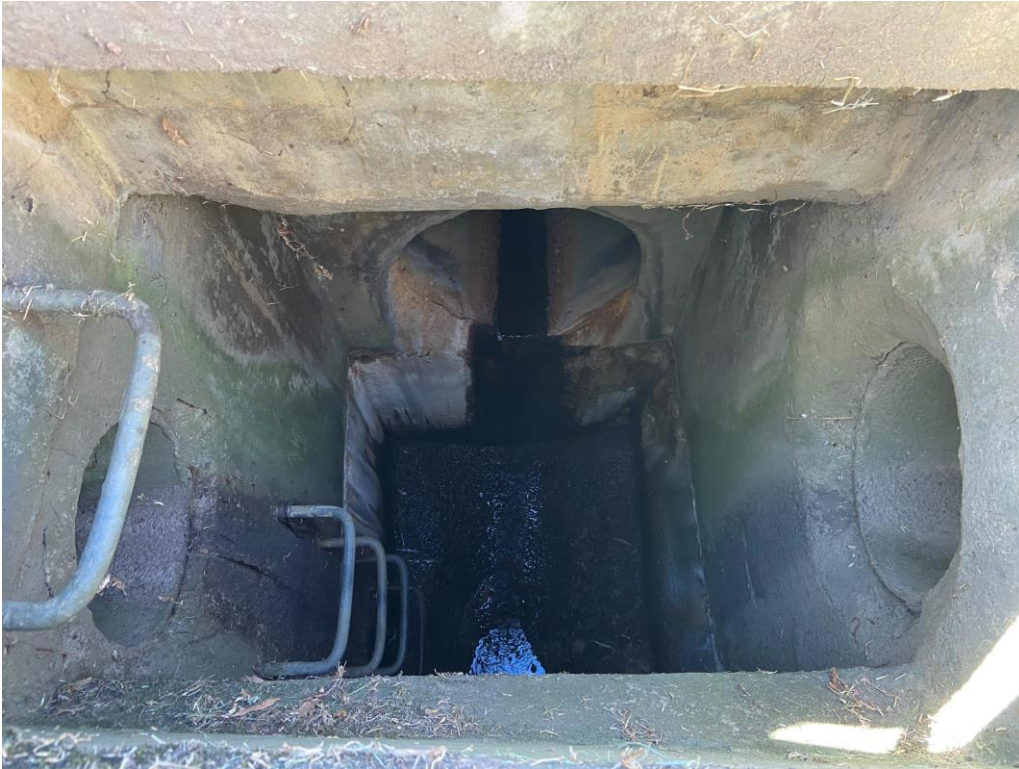
Figure 42: Photograph supplied by SEW, taken on 5 March 2025, showing water flowing into pit opposite 6 Waller Place.

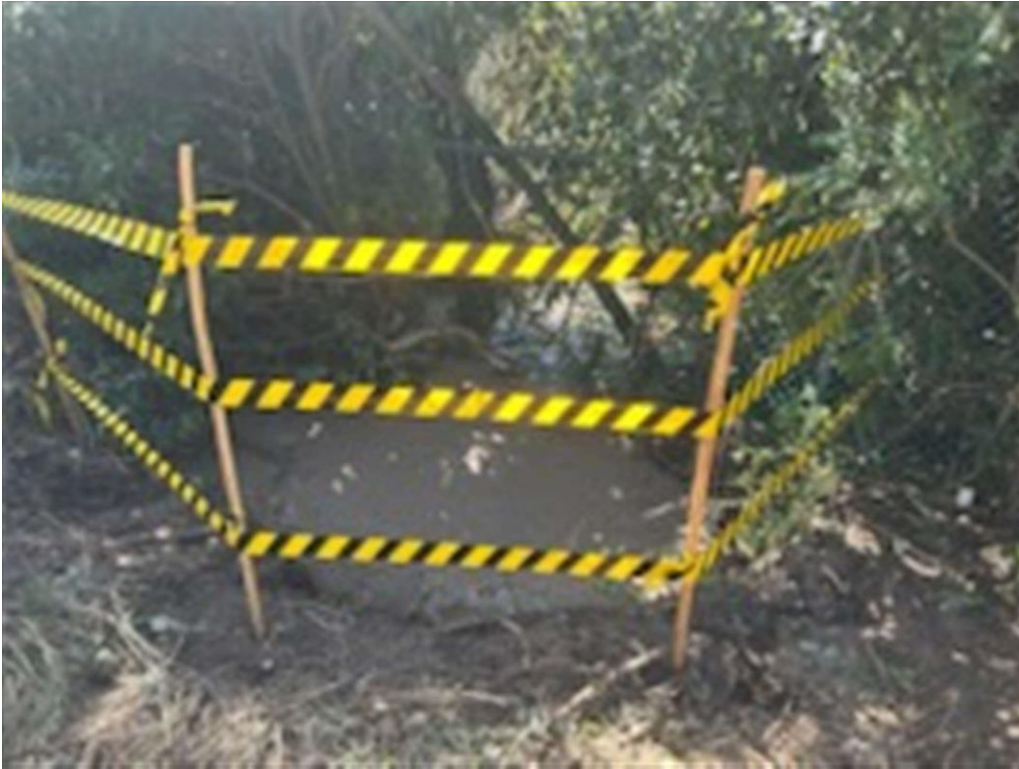
Figure 43: Provided by SEW, understood to have been taken on 31 December 2024, showing site condition upon arrival at the Bayview Road leak site. Note the ponded water, and flowing runoff into the background.

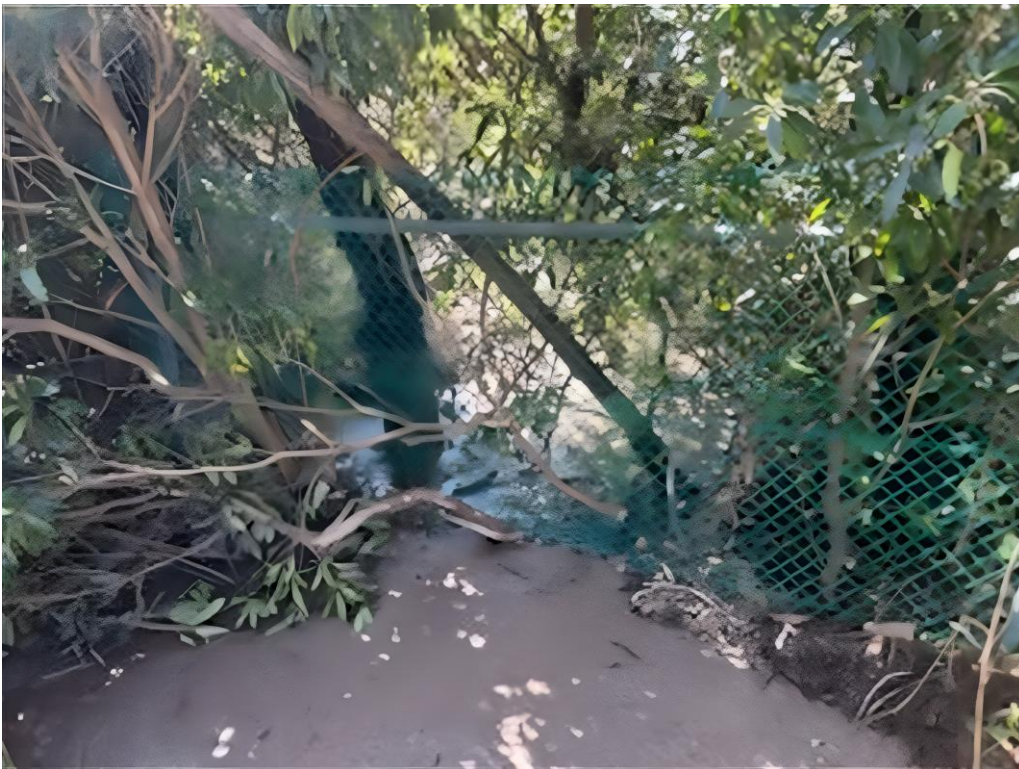
Figure 44: Provided by SEW, understood to have been taken on 31 December 2024, showing detail of ponded and flowing runoff at the Bayview Road leak site

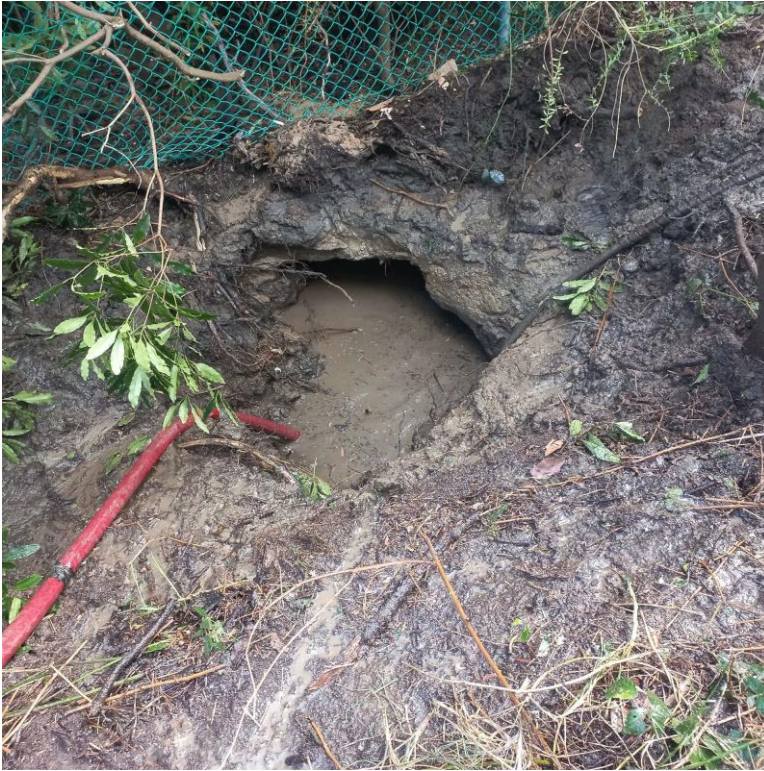
Figure 45: Provided by SEW, understood to have been taken on 31 December 2024, showing the ground collapsing during water pumping at Bayview Road leak site. Hole assumed to have been excavated by small excavator on site at the time.

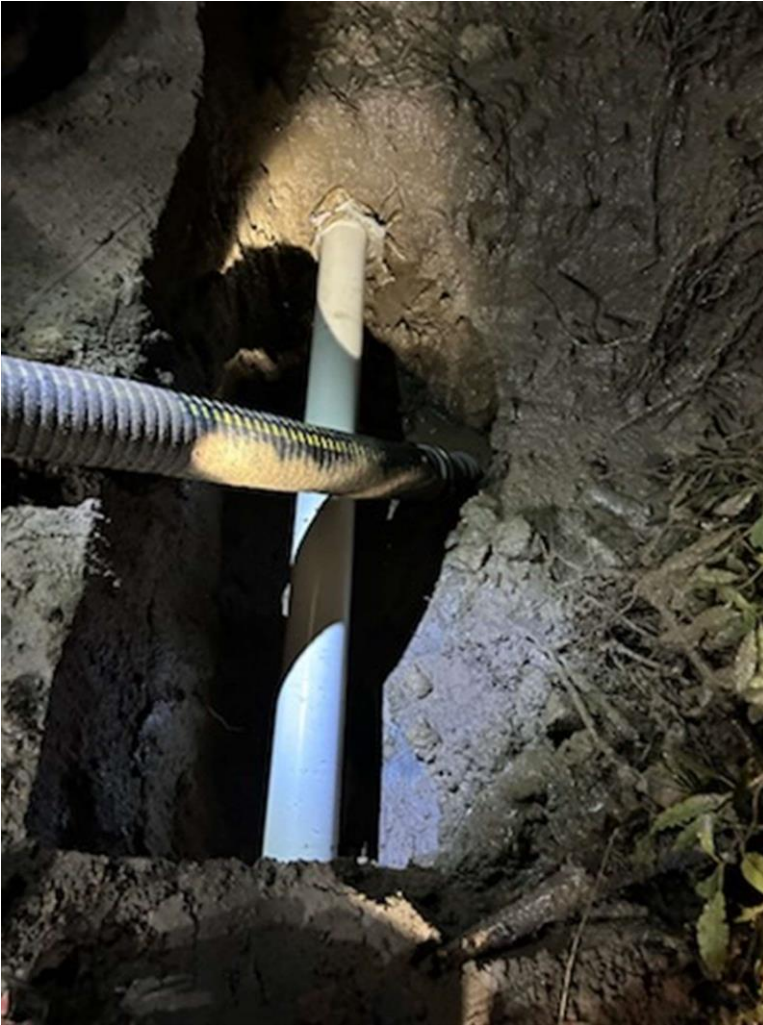
Figure 47: Provided by SEW, understood to have been taken on 1 January 2025, at the Bayview Road leak site showing exposure of pipe. Indicating the fracture is at the bottom of the pipe.

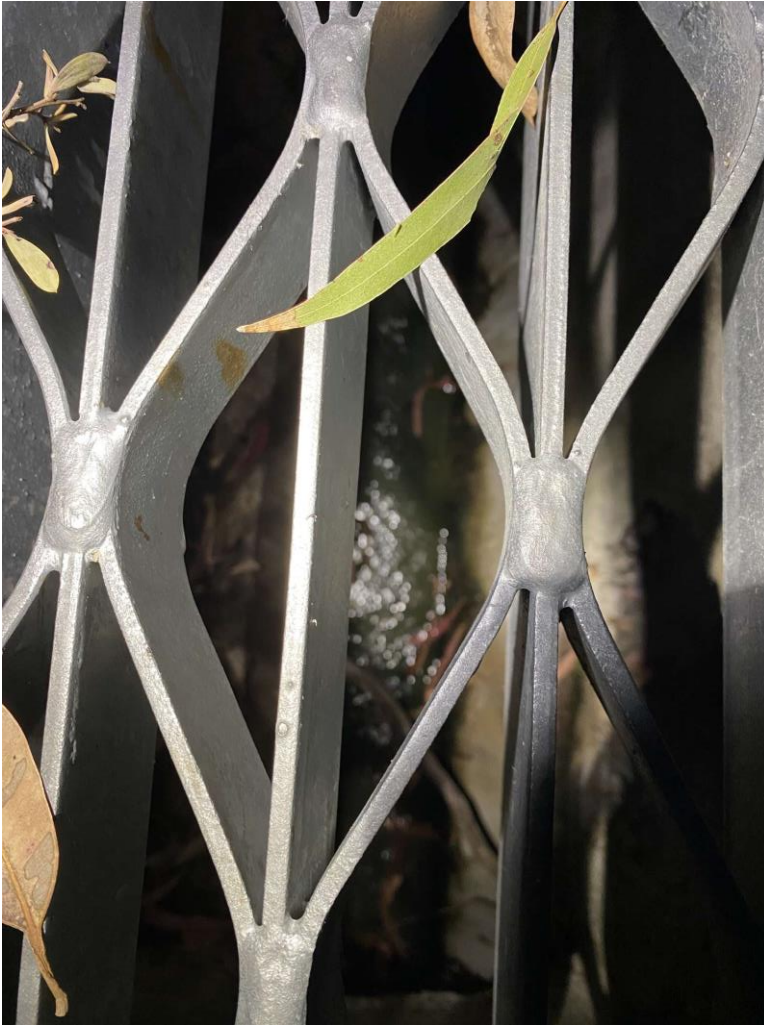
Figure 50: Photograph taken on the night of 5-6 January 2025, Showing flowing water within the stormwater drain shown in Figure 49.

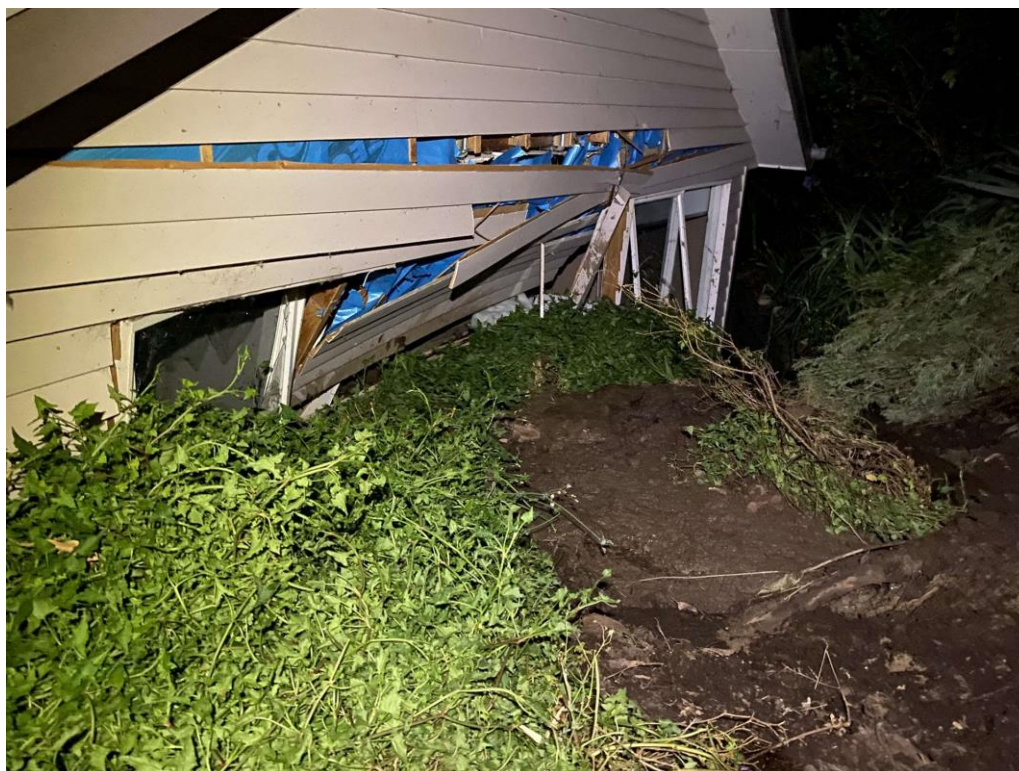
Figure 52: Photograph taken on the night of 5-6 January 2025 showing landslide debris against rear wall of 3 Penny Lane

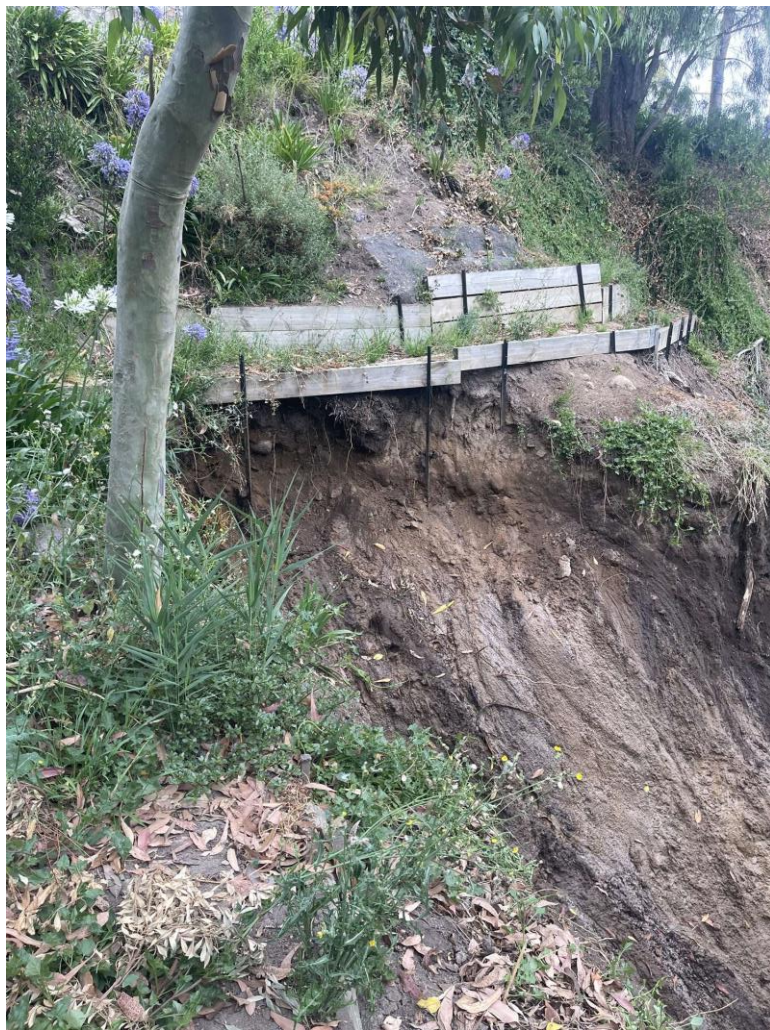
Figure 53: Photograph taken on 6 January 2025 looking west across the backscarp of the failure.

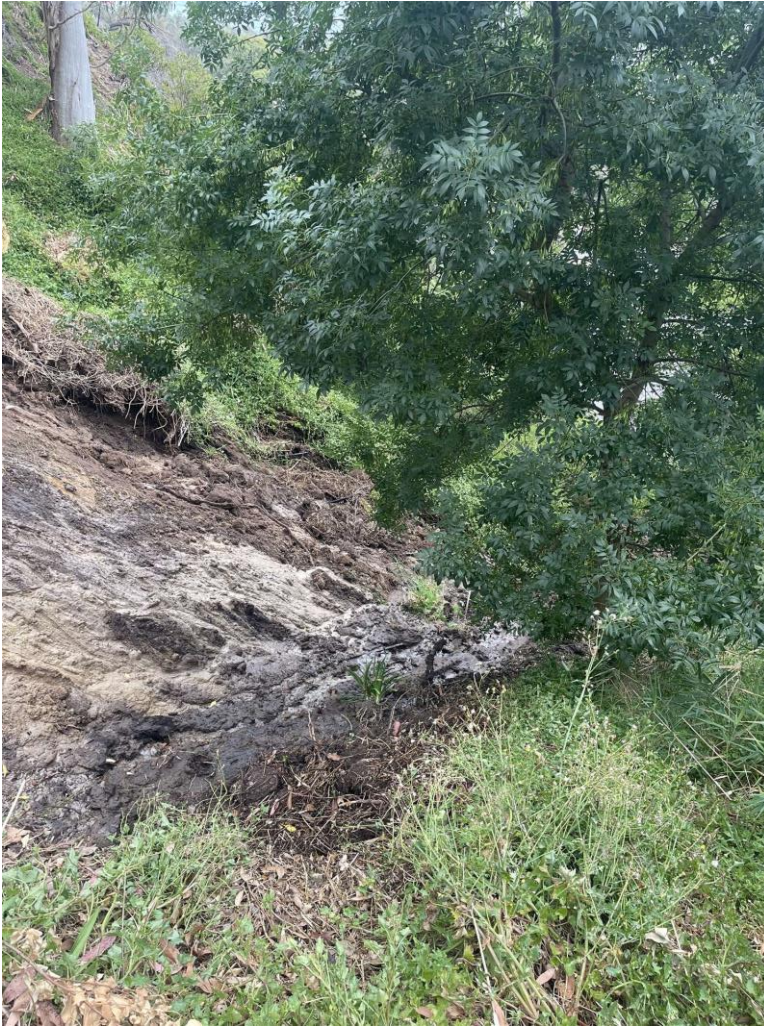
Figure 54: Photograph taken on 6 January 2025, looking downslope showing debris slide below the backscarp.

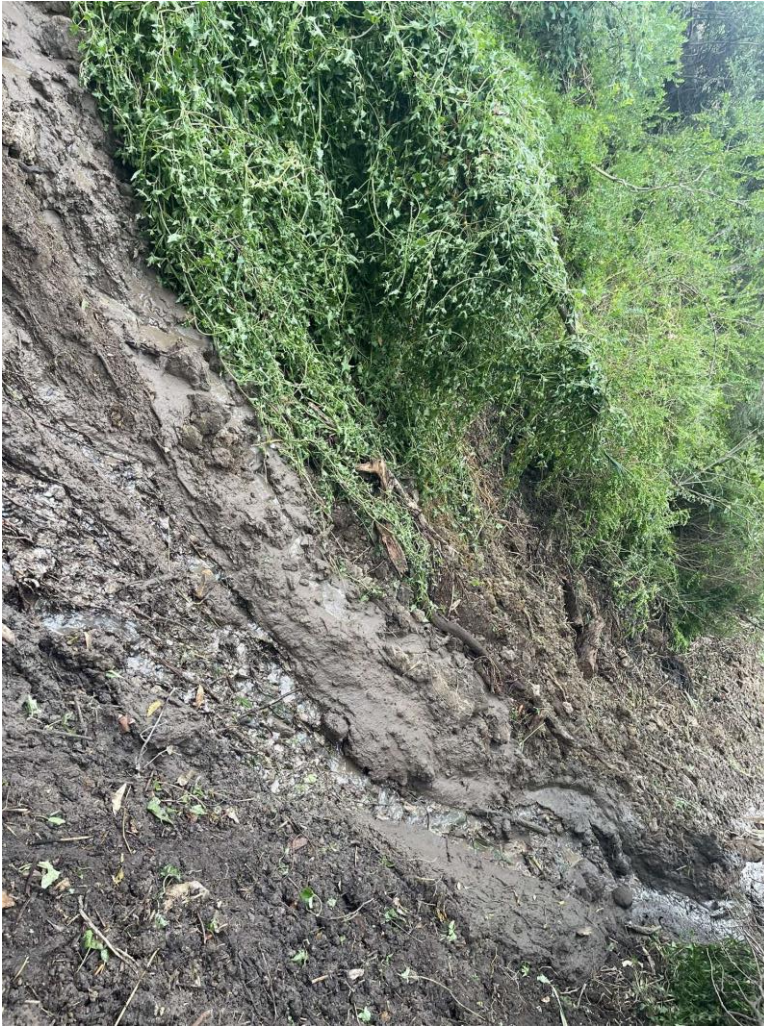
Figure 55: Photograph taken on 6 January 2025, showing slip debris of the 5 January 2025 landslide and water channel cutting through debris. The adjacent vegetation may indicate the original ground level and vegetation cover prior to the failure.

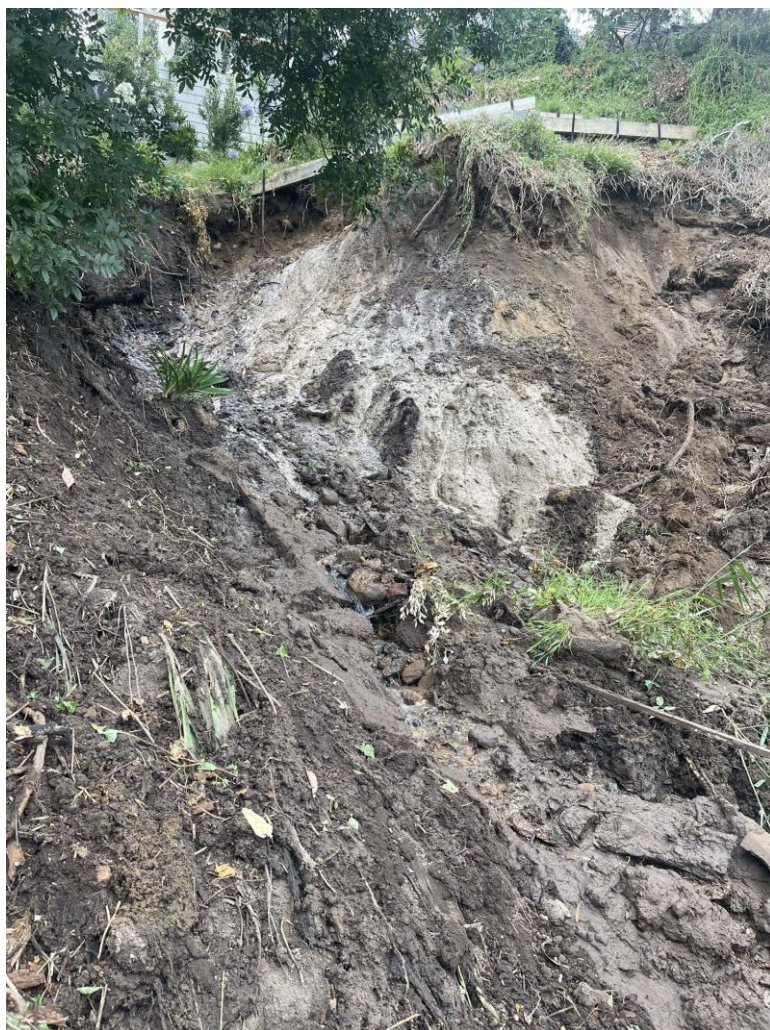
Figure 56: Photograph taken on 6 January 2025, looking up at the landslide, showing saturated debris flow surface with dry soil adjacent. Debris may include some boulders cobbles, but also anthropogenic and vegetation material
