South East Water Submission to the Board of Inquiry into the McCrae Landslide

April 2025

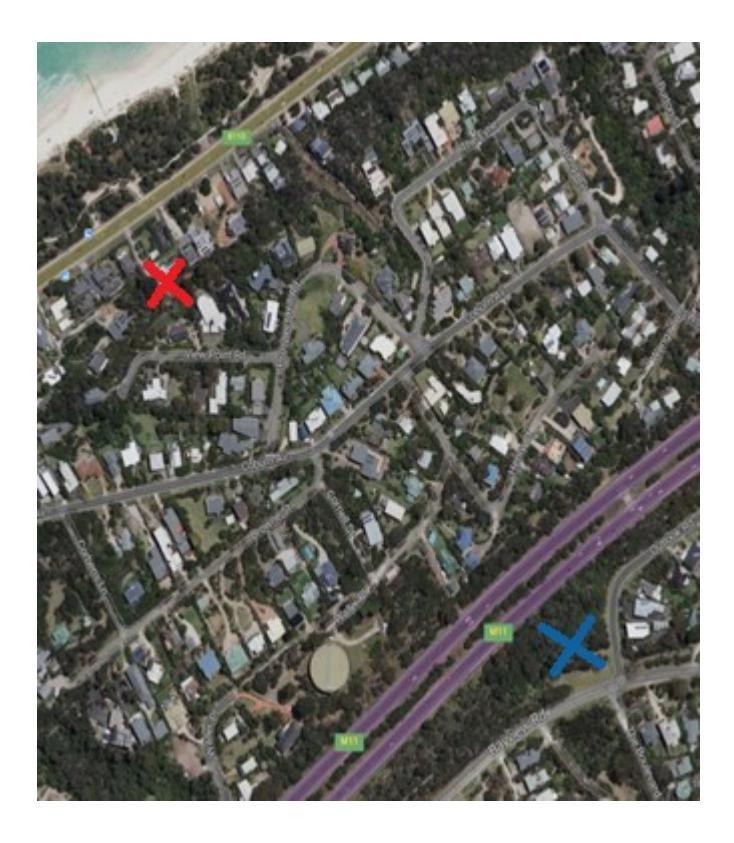
On 30 December 2024 at approximately 1pm SEW first became aware there was a burst on Water Main 104961. The burst was located on the edge of densely vegetated bushland between Bayview Road and the Mornington Peninsula Freeway, approximately 50 metres west of Outlook Road. A map showing the location of the water main burst, approximately 450 metres from the Landslide site, is at Figure 2. A photo showing the site of the water main burst is at Figure 3.

Figure 22 - Map showing locations of Bayview Road burst (blue) and the Landslide site (red)

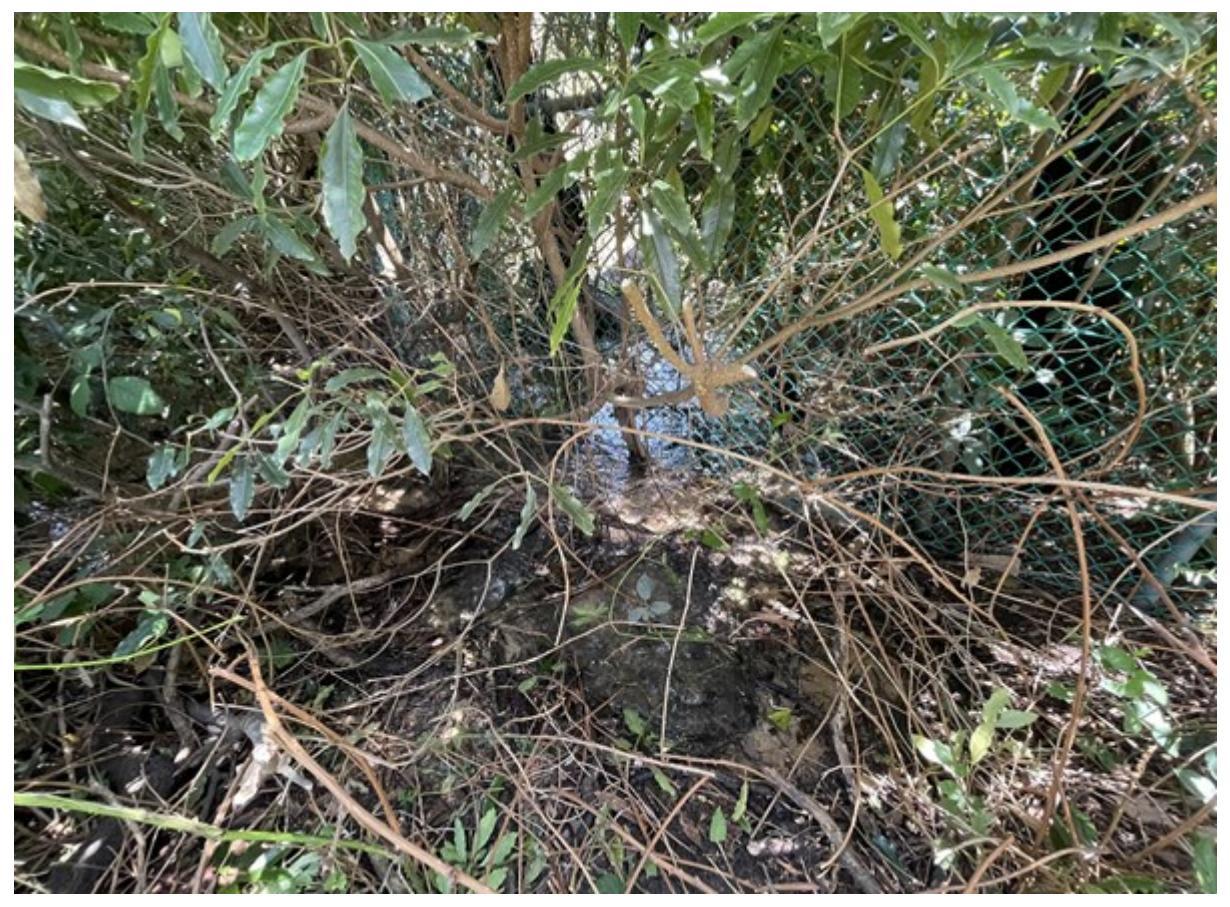
Figure 33 - Photo of the site of the Bayview Road burst, located in bushland

The Bayview Road water main burst was not readily detectable owing to: its location in bushland; distance approximately 150 metres from the area in Waller place where water issues were initially reported, being on the other side of the freeway; and concurrent issues of surfacing groundwater.

- With approval from Council, removed fencing and trees to make site safe to work
- Identified small split approximately (100mm long) on the water pipe and repaired by replacing a 1 metre long section.

SEW and its contractors repaired the burst water main on 31 December 2024 – 1 January 2025. The repair was complex, involving tasks including the following:
