Legally Privileged Multidisciplinary Expert Report

McCrae Landslip Project

5 May 2025

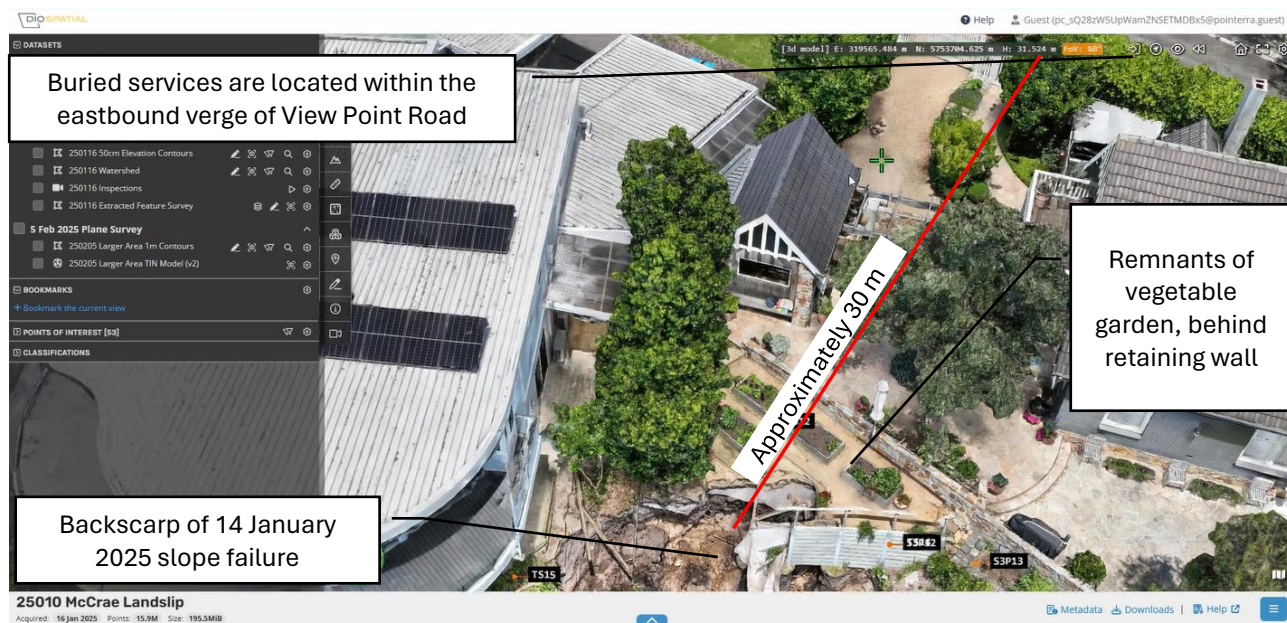
Figure 16: Drone footage showing the infrastructure, buildings vegetation and distance between View Point Road and the failure

The distance between the verge of View Point Road, the location of known SEW assets, and the failure, is approximately 30 m. Figure 16 includes View Point Road and the retaining wall, illustrating the approximate distance. Figure 16 also shows the vegetable garden behind the retaining wall, and mature tree.

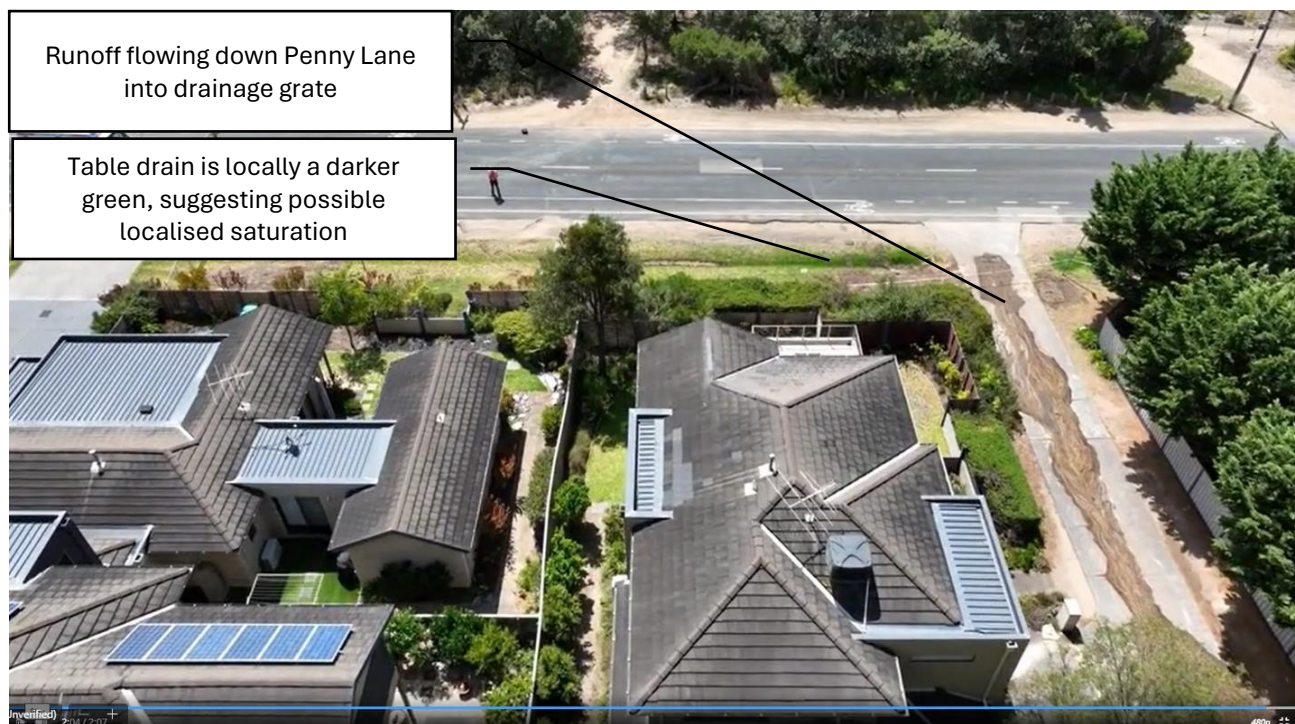
Figure 19: Drone footage from near the toe of the failure, looking towards Point Nepean Road.

Figure 19 shows water flowing down Penny Lane, and into a drainage grate, then flowing into a table drain. The surface area near the grate, is greener than the remaining length of drain.

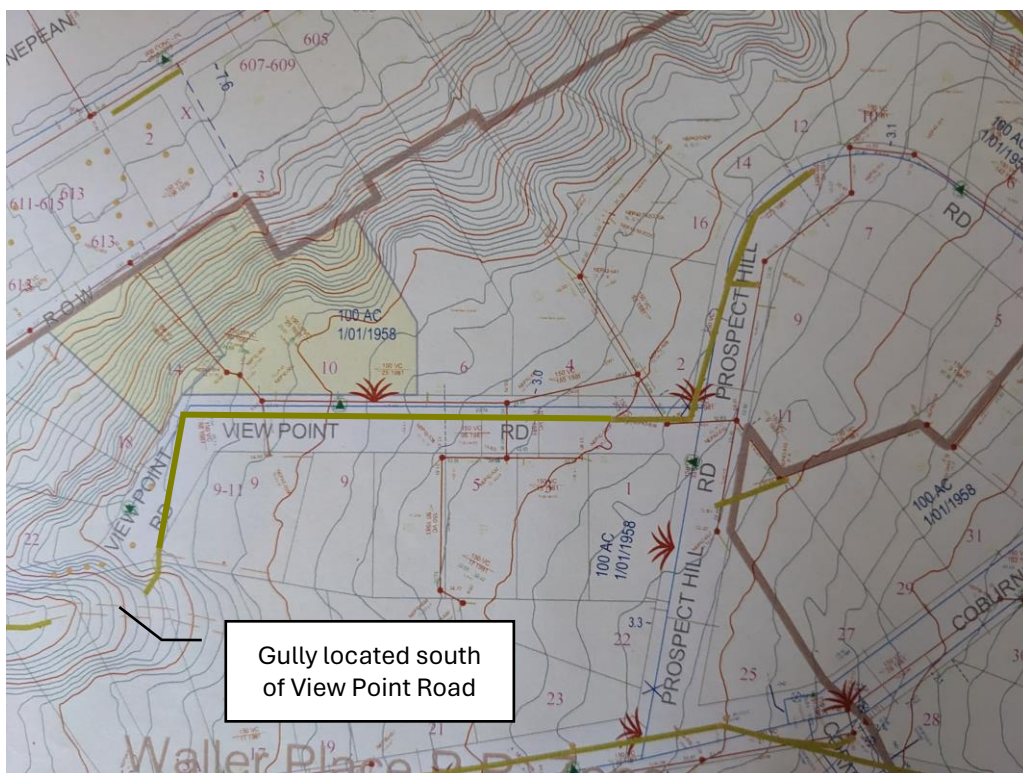
Figure 32: Excerpt of SEW map showing location of View Point Road and Prospect Hill Road.

Figure 32 also shows the topography of the locality. Note a gully that falls westwards, south of the turning circle of View Point Road. This is away from the subject site.

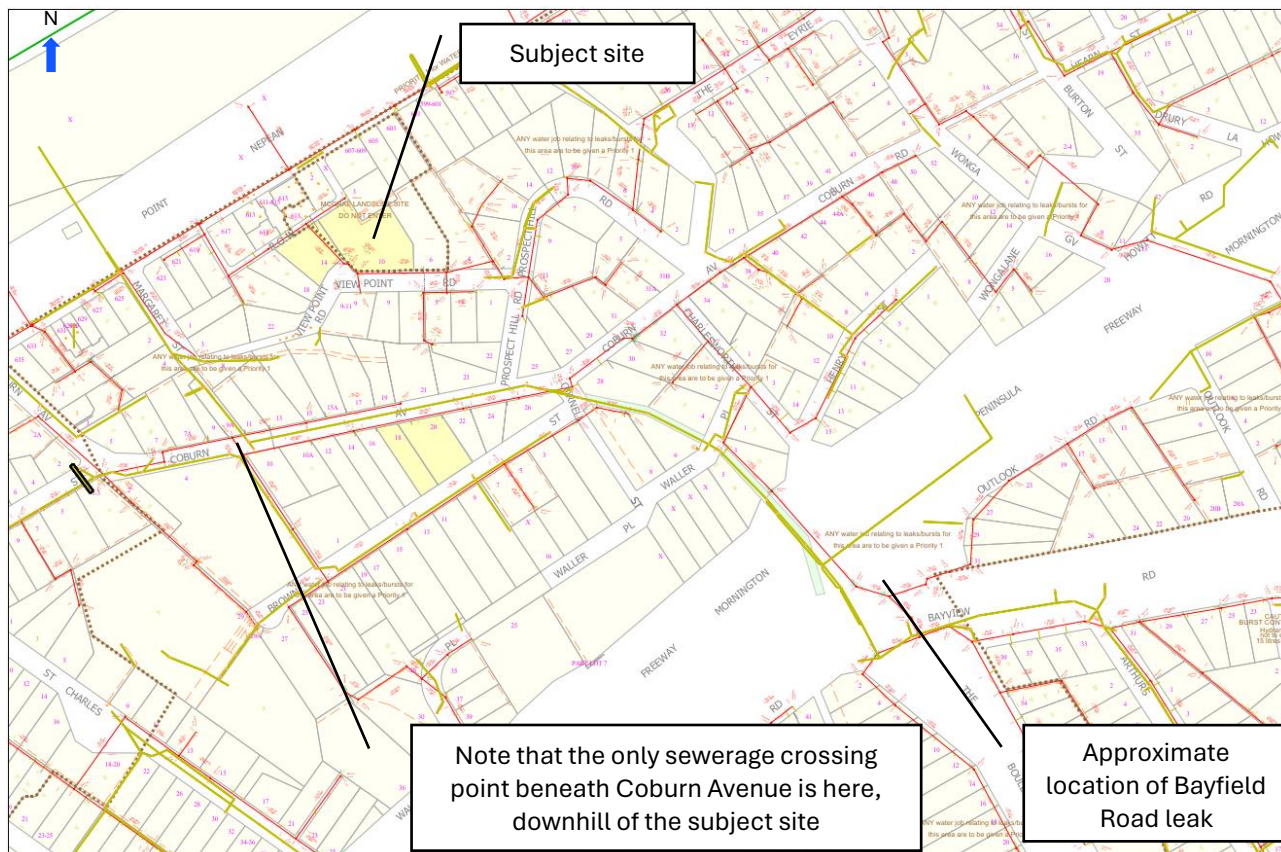
Figure 35: Plan showing sewerage network around locality of View Point Road. Note that the leak near Bayview Road is the south side of Mornington Freeway.

Figure 35 shows the location of buried sewer assets in the locality of View Point Road. It should be noted that the ground level tends to dip towards the northwest. There is no link between the sewer network of Prospect Hill Road and View Point Road, and the network south, or uphill from Coburn Avenue, as illustrated in Figure 58.

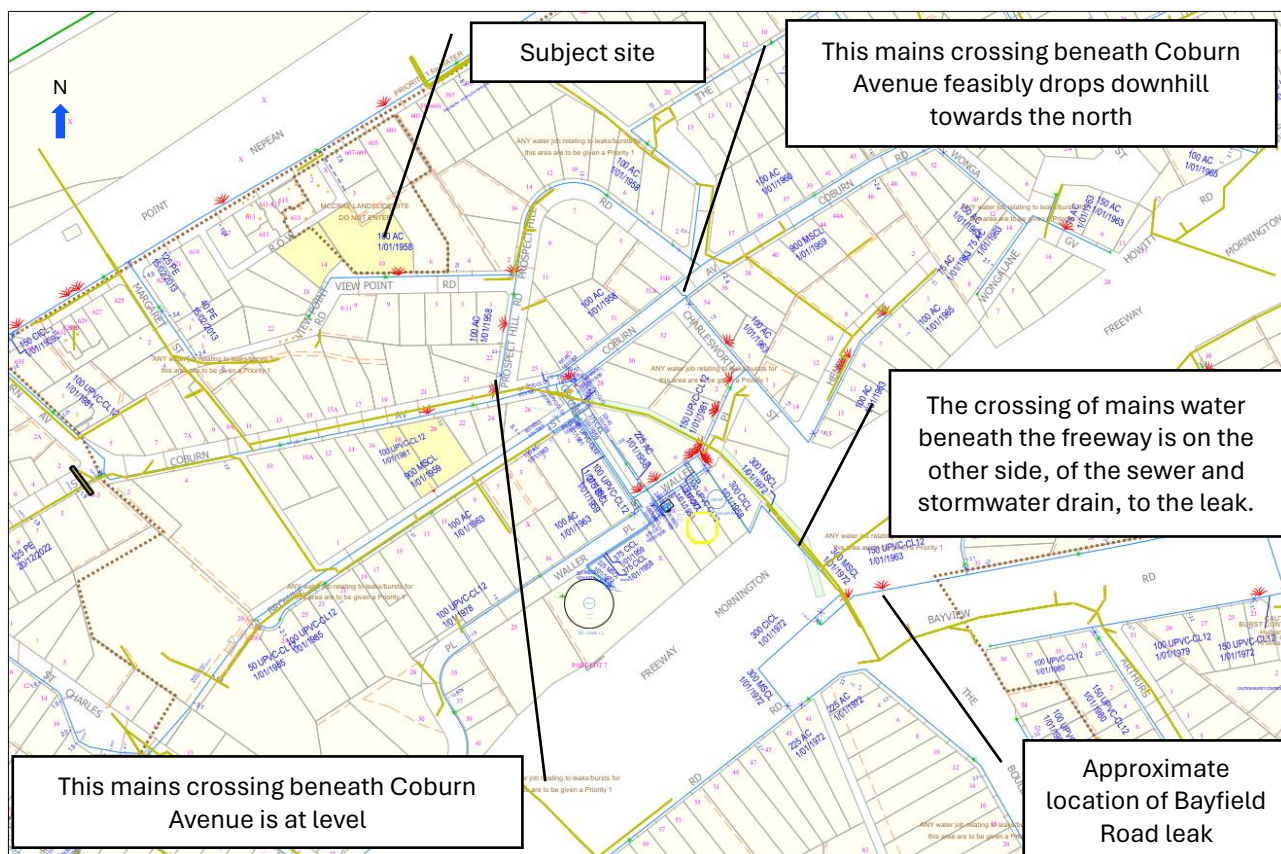
Figure 36: Plan showing water mains network around the locality of View Point Road.

Figure 36 illustrates that the link within the mains network at the T-junction of Prospect Hill and Coburn Avenue is level. This is not a concern for pumped water flow, but it indicates that the embedment material surrounding the mains, grades upwards towards Prospect Hill Road.

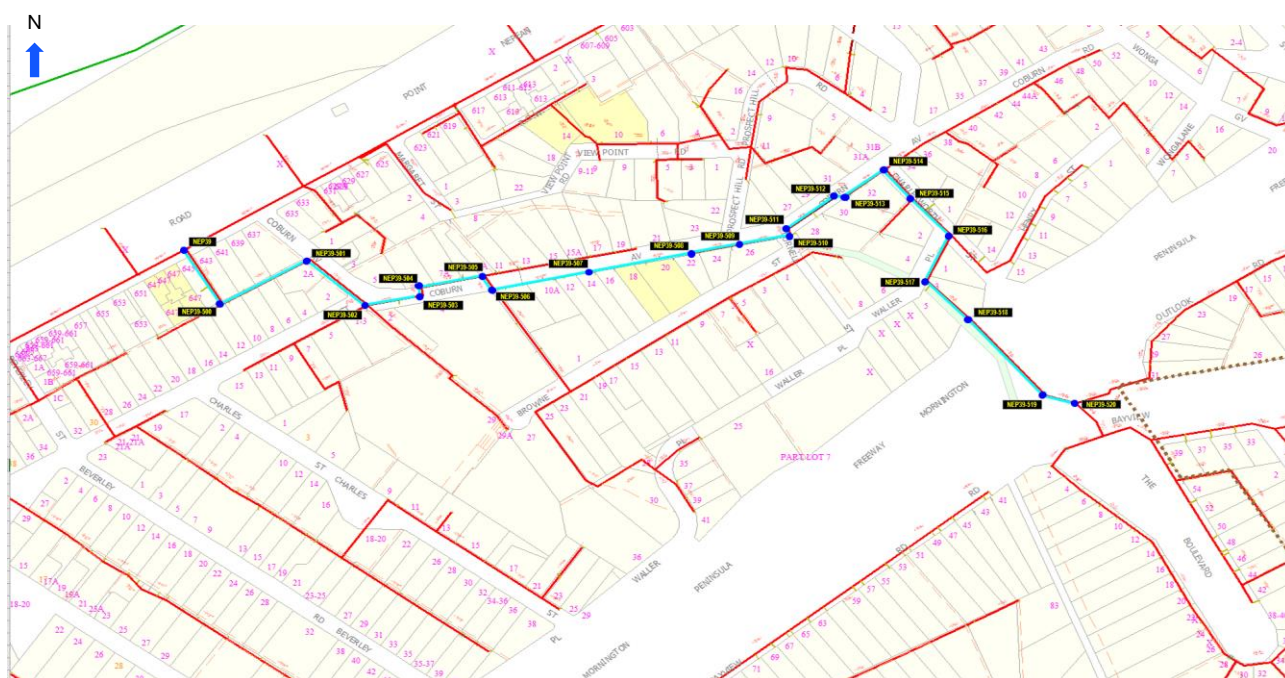
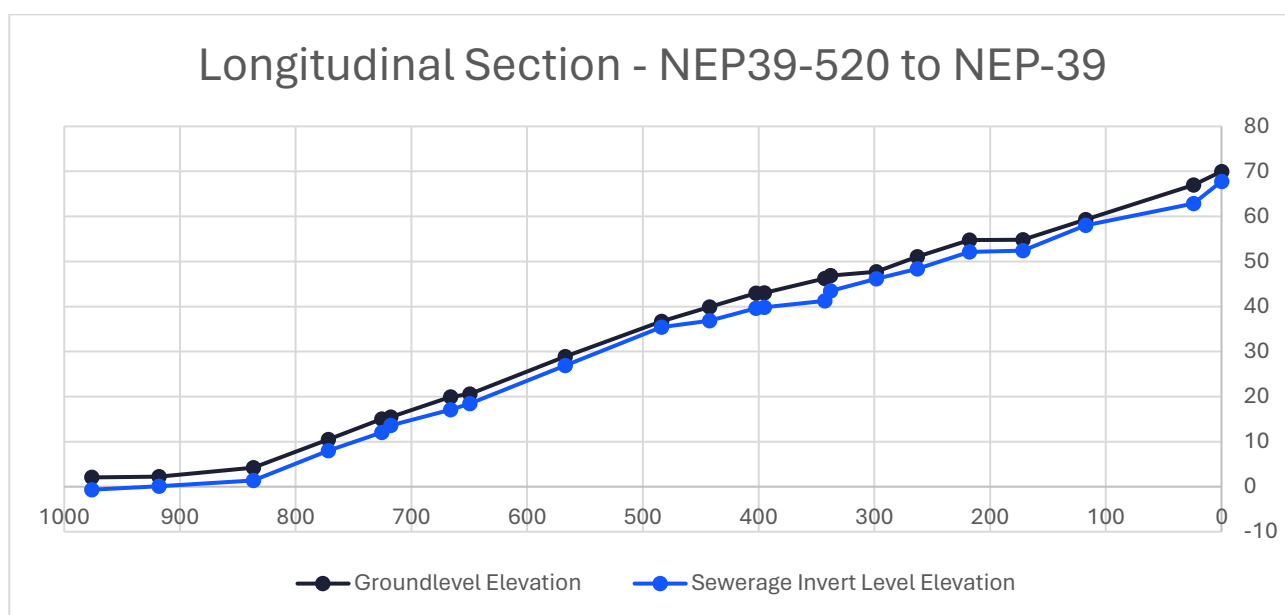
Figure 37: Map showing sewer network from Bayview Road and Point Nepean Road.

Figure 38: Graphical long section showing the ground level and invert levels of the sewer network between Bayview Road and Point Nepean Road

Figure 37 and Figure 38 illustrate the gradient through Bayview Hill Road into Point Nepean Road. Chainages 217.75 m to 298.25 m are located along Charlesworth Street, where upwelling was noted (Section 7.6.3.2). The depth to invert along Charlesworth Street varies from 2.69 m to 1.56 m. It is noted that the invert depths along Charlesworth Street are not the shallowest inverts along the alignment. It is therefore not certain that the depth to invert is solely related to the likelihood of upwelling.

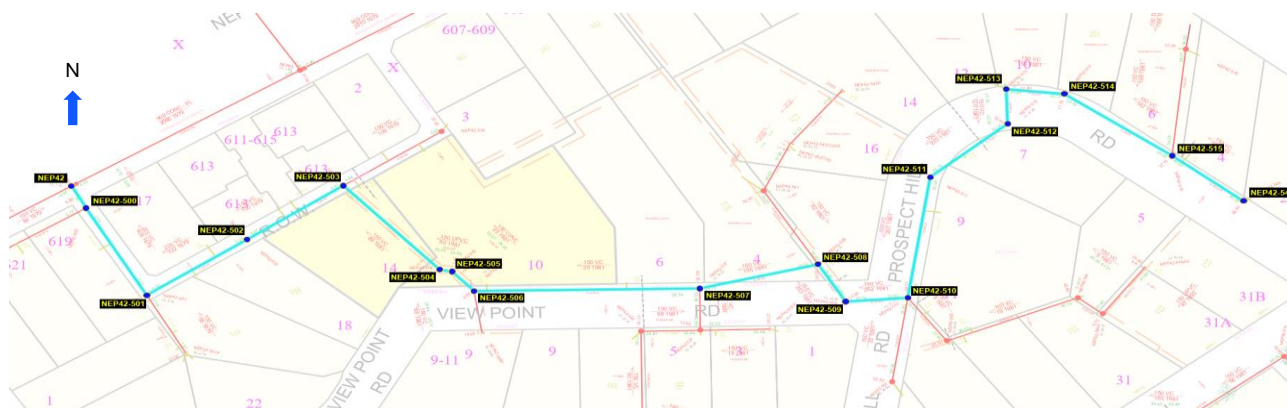
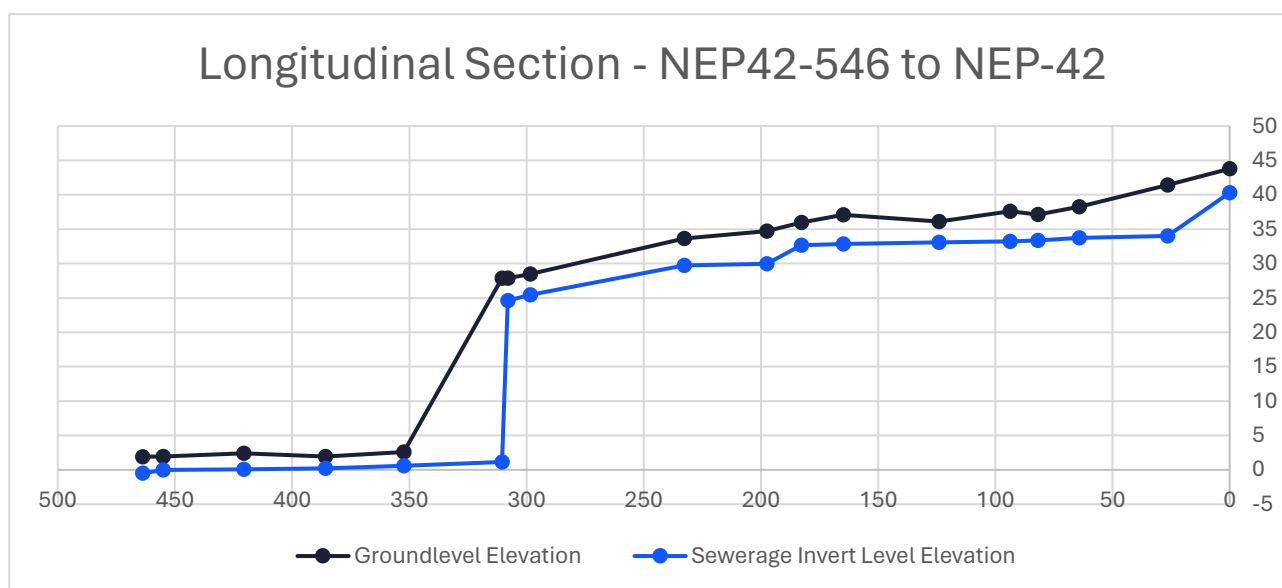
Figure 39: Map showing sewer network from Prospect Hill Road and Point Nepean Road.

Figure 40: Graphical long section showing the ground level (CL) and invert levels (IL) of the sewer network between Prospect Hill Road and Point Nepean Road.

Figure 39 and Figure 40 illustrate the gradient through Prospect Hill Road into View Point Road. Note that the scales differ from Figure 37 and Figure 38. Note that 10 View Point Road is at chainage 298.4 m. The figures show a fall in invert level along the chainage, irrespective of the ground level. Note that Chainage 83.9m to 93.7m, is outside 10 Prospect Hill Place.

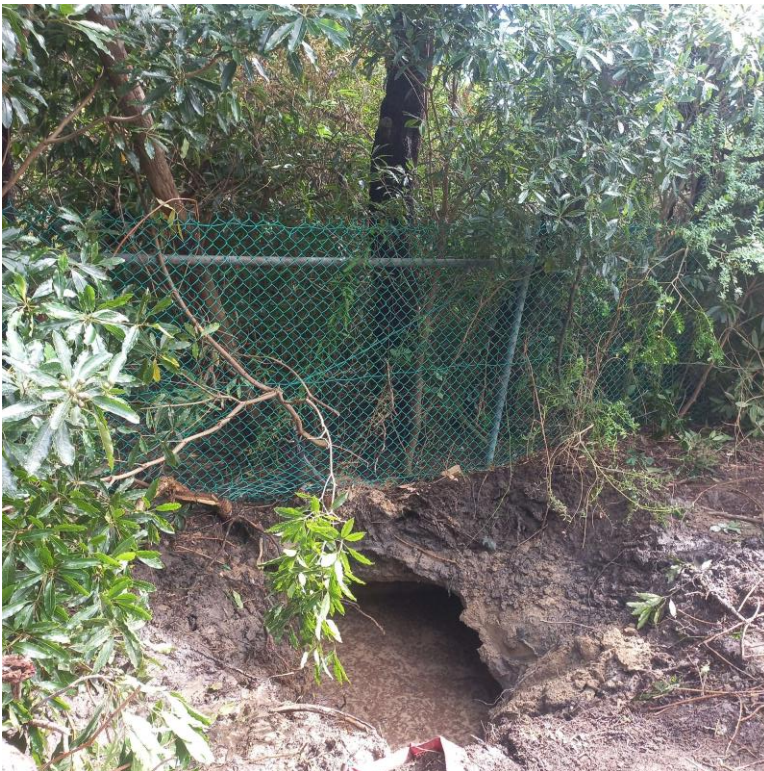
Figure 46: Provided by SEW, understood to have been taken on 31 December 2024, showing the Bayview Road leak site during pumping and excavation works.

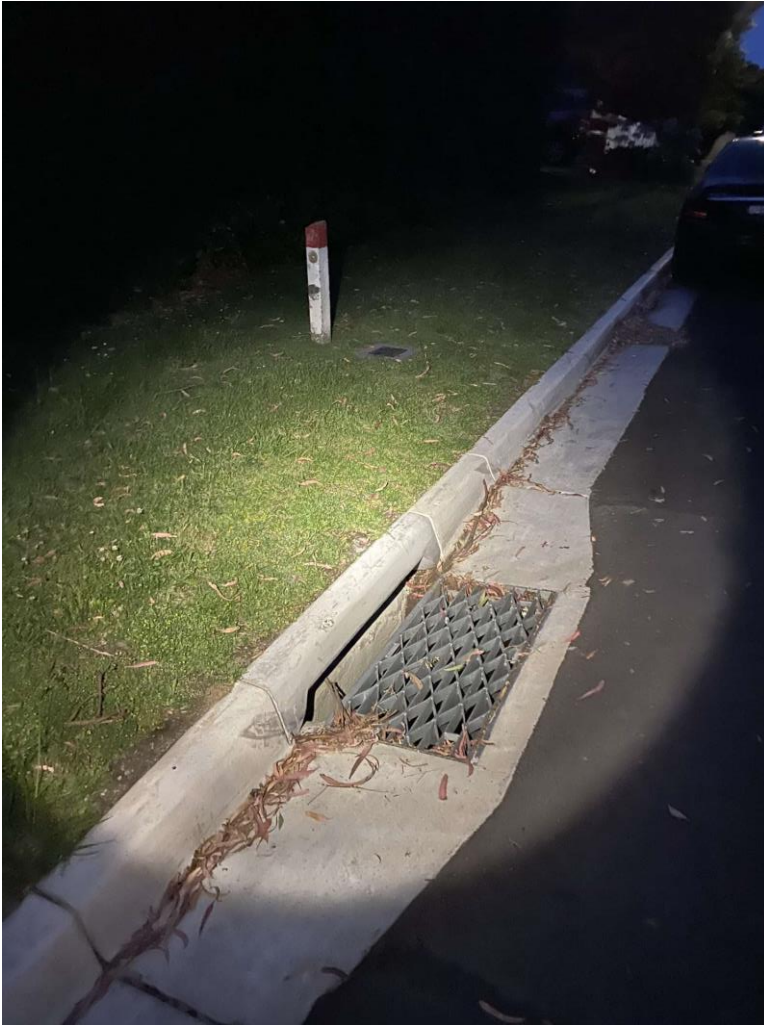
Figure 49: Photograph taken on the night of 5-6 January 2025, of a stormwater drainage pit outside what is thought to be No. 10 View Point Road

Figure 49 shows a storm water pit with a grate. The accompanying records from SEW personnel do not explicitly say where this pit is. However, based on locations of fire hydrants and recognisable fences, SMEC believe it is outside No. 10 (see Figure 6).

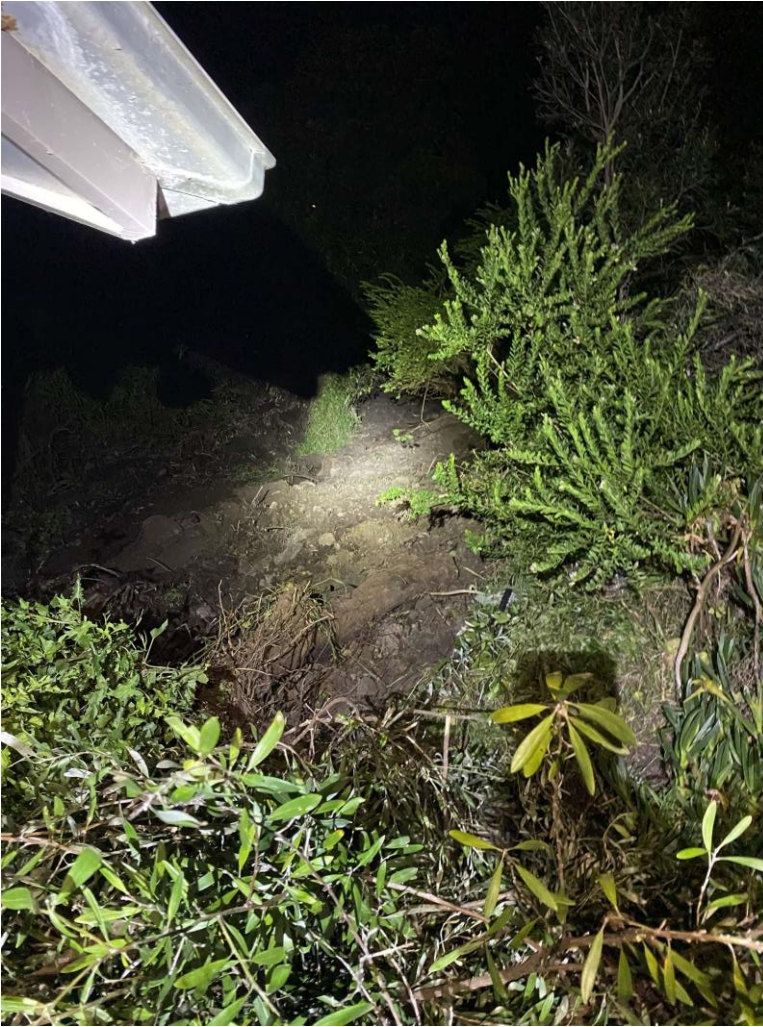
Figure 51: Photograph taken on the night of 5-6 January 2025, looking south from behind 3 Penny Lane

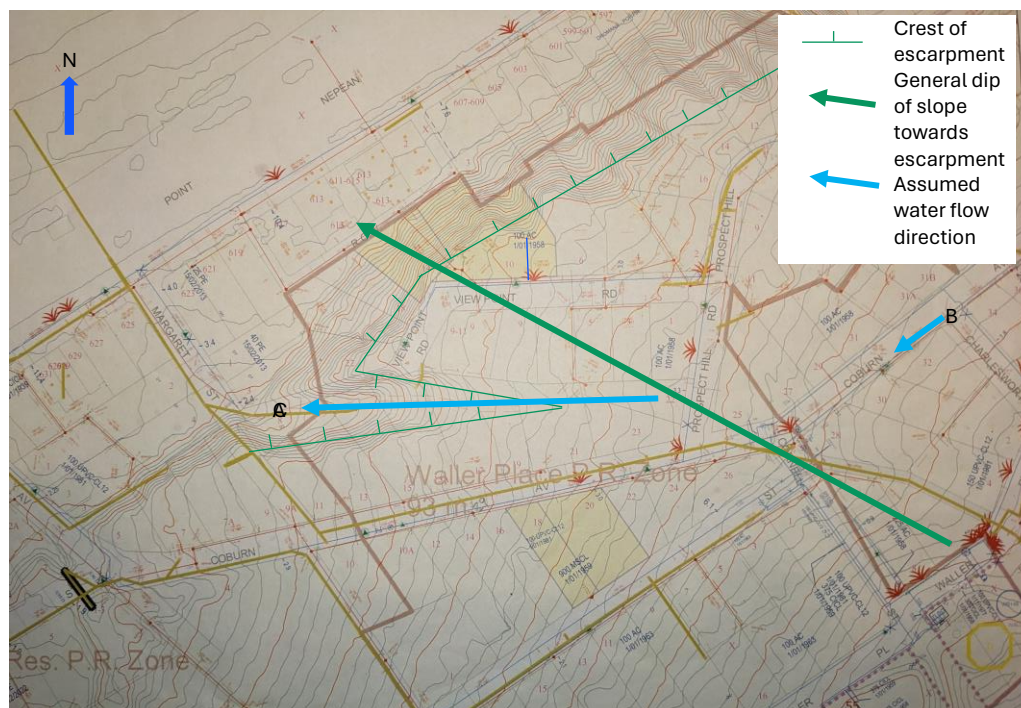
It is considered **not** possible that a leak close to the site could create such conditions without other evidence of deterioration being observed at the surface.

Figure 57: Map illustrating the evidence needed to confirm the hypothesis that the McCrea Landslide was impacted by a leak within SEW assets in the vicinity of the subject site

Figure 16 and Figure 32 illustrate the distance between the landslide and the location of the water main (located within the verge of View Point Road) is approximately 30 m. The ground level tends to drop across the alignment of View Point Road (see the green arrow, Figure 57).

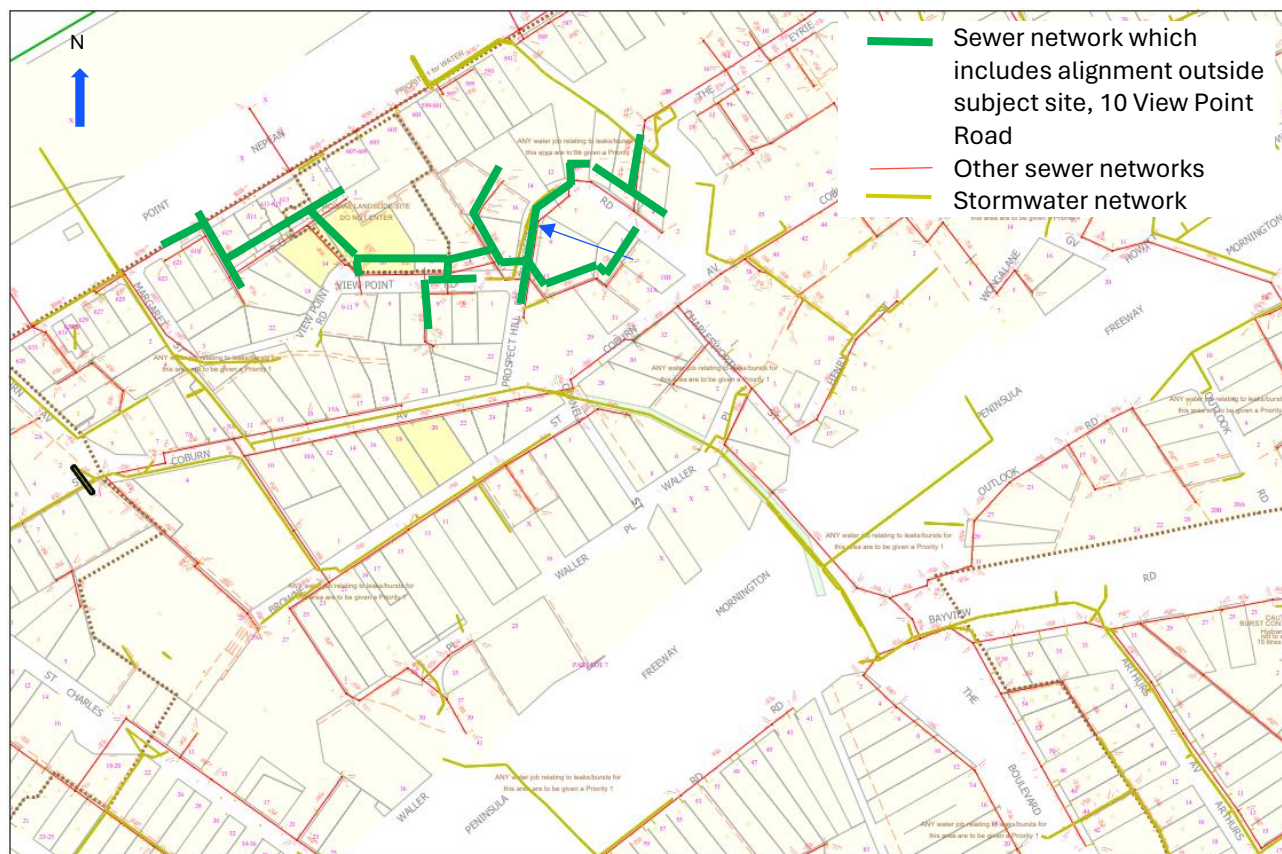
Figure 58: Map illustrating the evidence needed to confirm the hypothesis that the McCrae Landslide was impacted by a leak within SEW assets in the vicinity of the subject site

This means that there is no contiguous trenched network associated with the sewerage that could allow water from significantly uphill of the subject site to reach the site.

The network that connects View Point Road, taking account of gravity, is limited to the green annotated network in Figure 58.

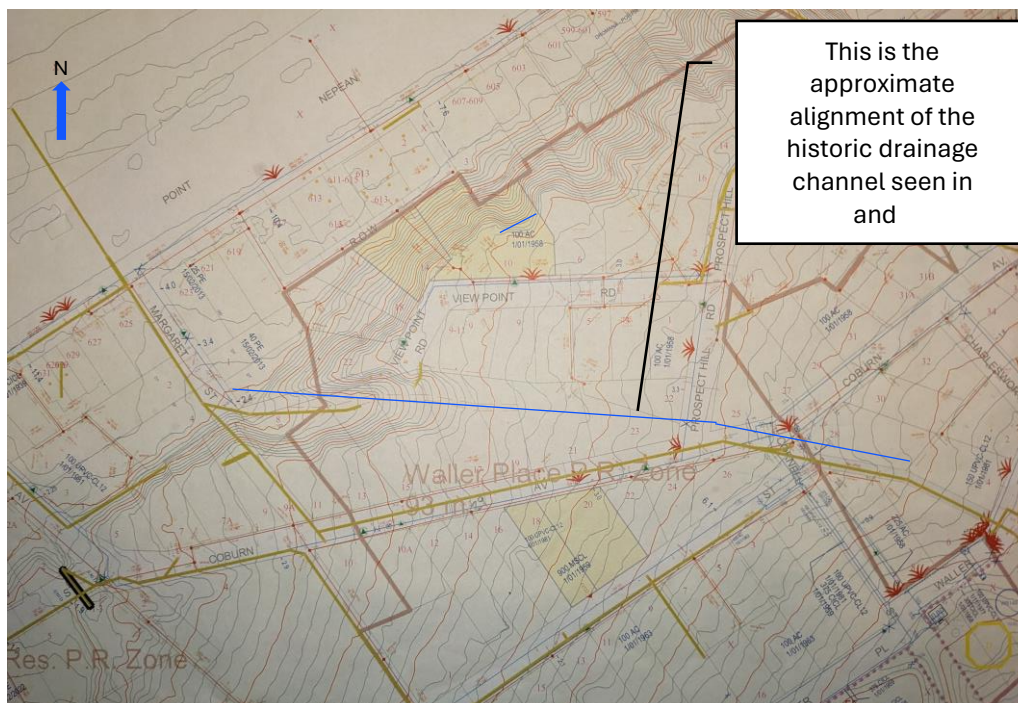
- A single leak 465 m uphill from the landslide,
 - Creating water flow across a historic surface water channel that outfalled at Margaret Road (Figure 59),
 - but also, across a modern cut that takes the Mornington Peninsula Freeway past McCrae (Drawing 003), and

Figure 59: Map illustrating the historical drainage channel in the locality of the subject site, in the context of current development

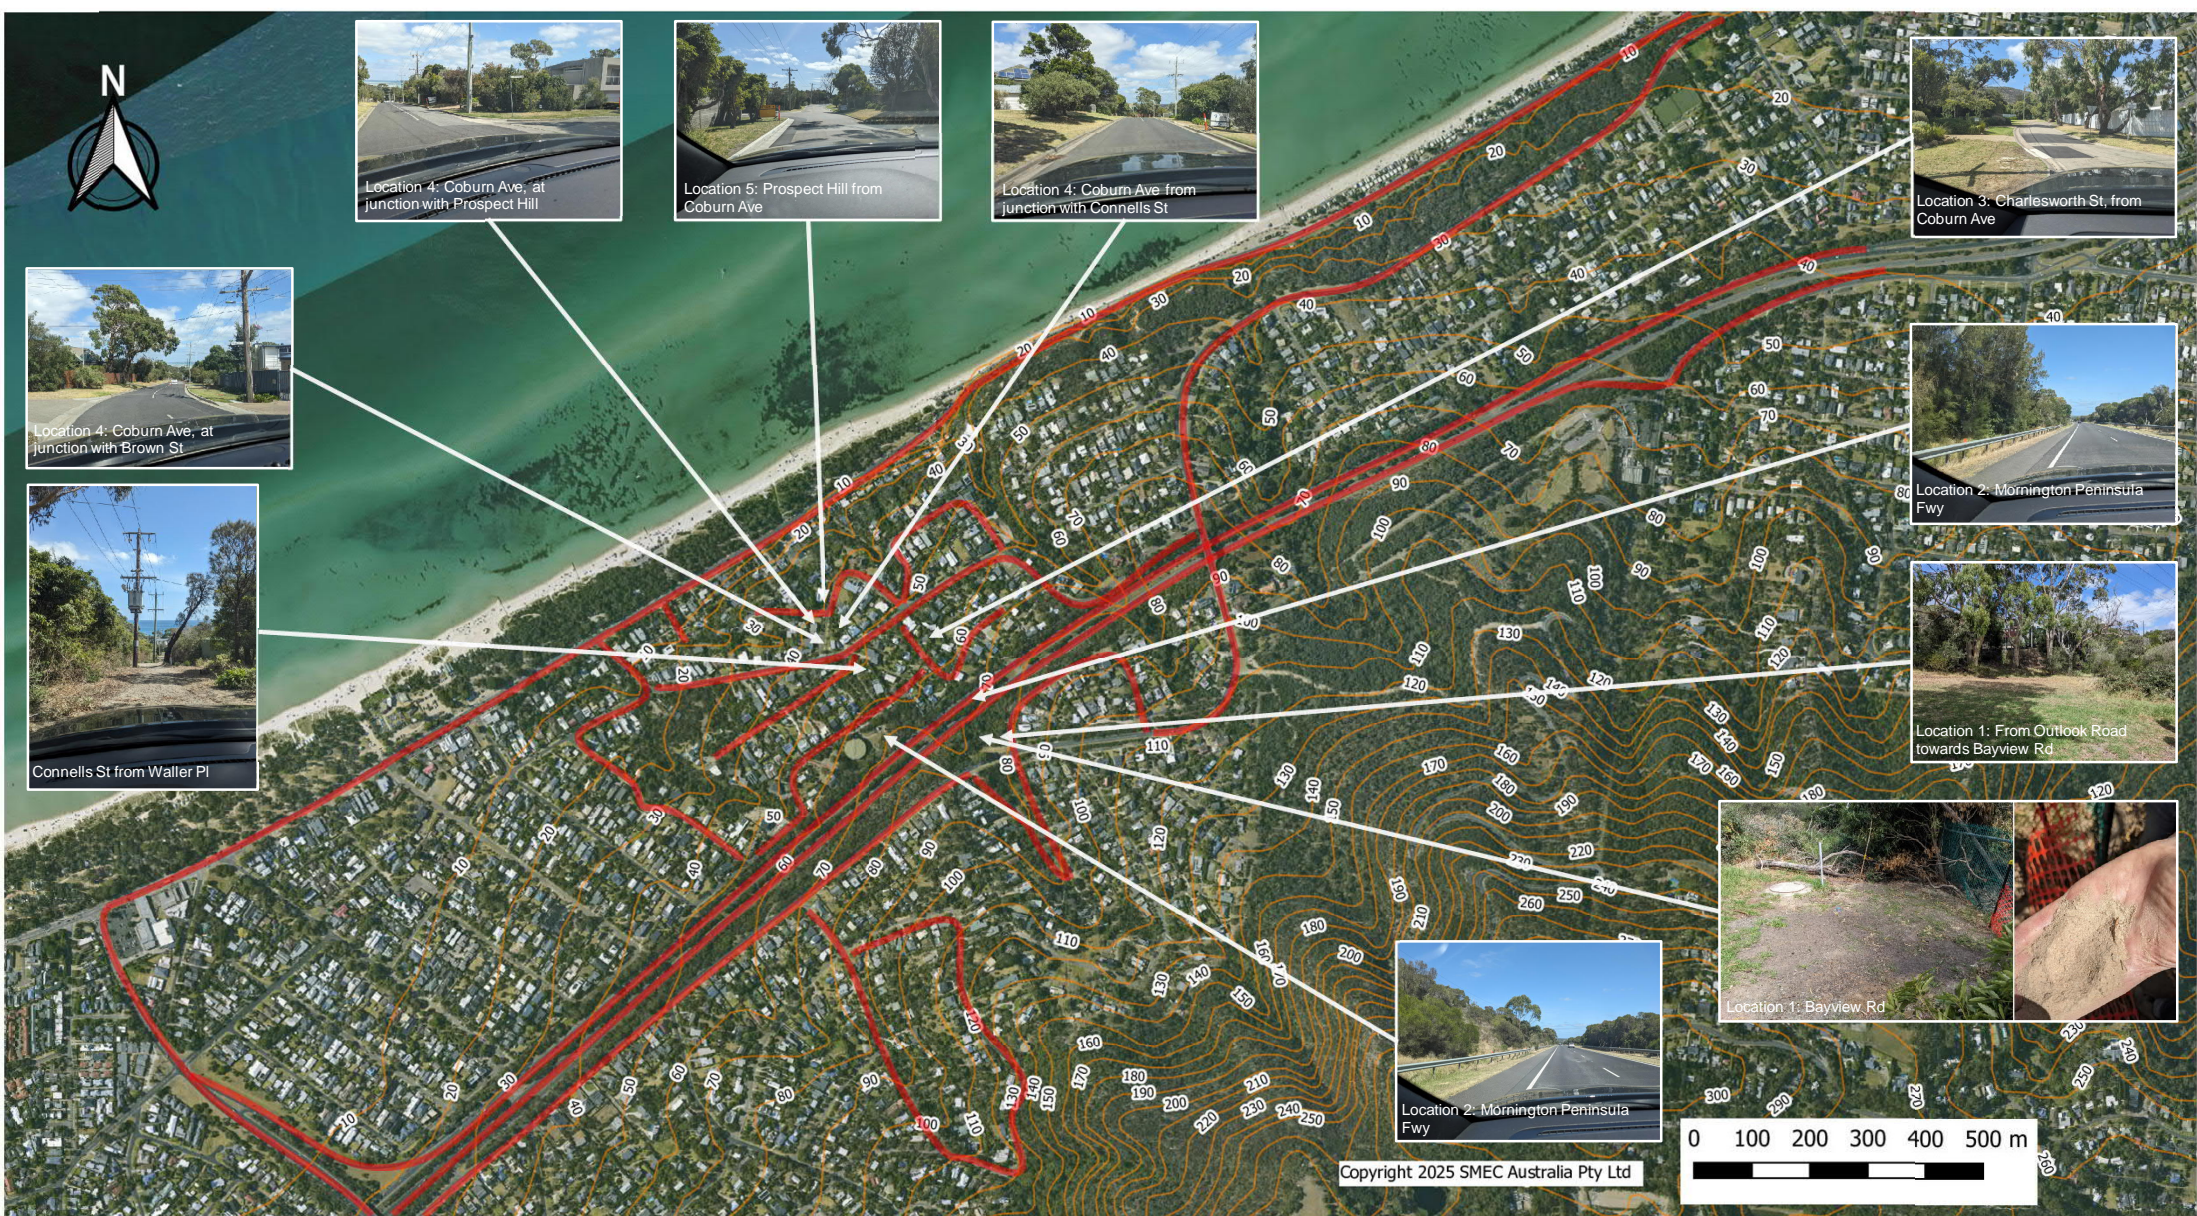
FIGURE TITLE: Drawing 001 - Aerial photograph of the locality of the subject site, showing roads driven during the site visit of 3 March 2025, and select photos taken during the site visit

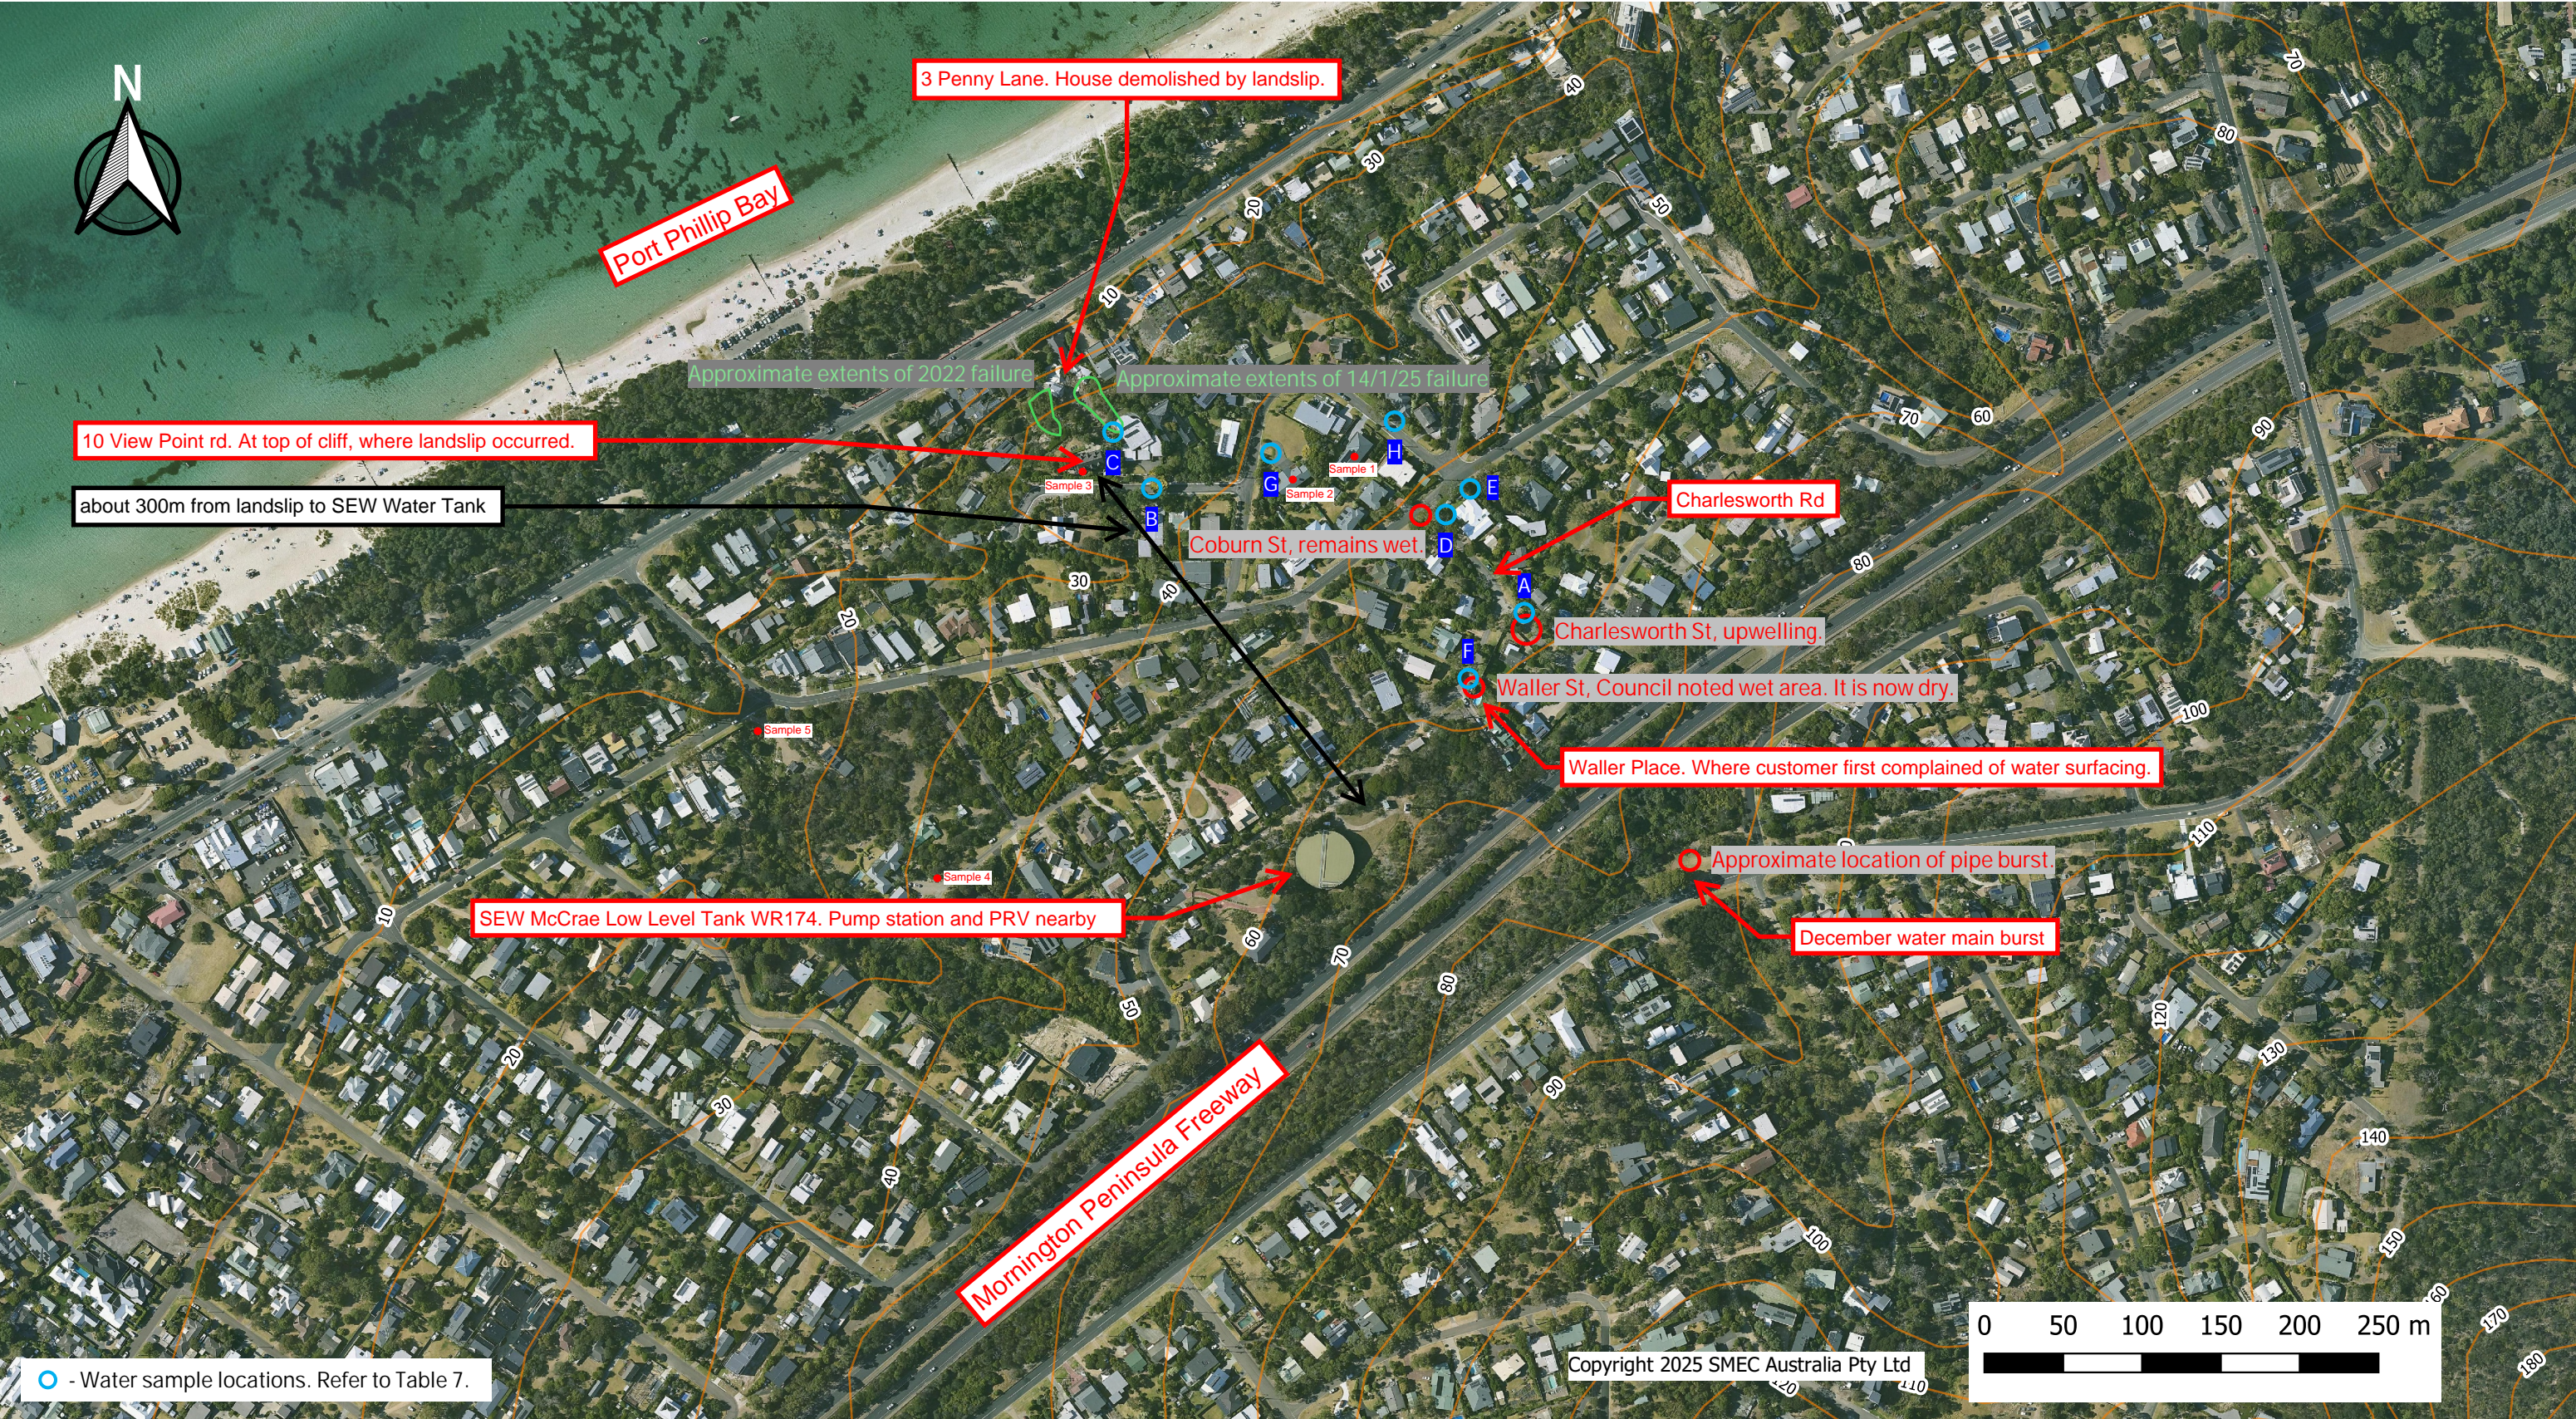
Records of known storage facilities, or buried pipelines show that (see Drawing 002, Figure 35 and Figure 36):

FIGURE TITLE	Drawing 002 - Aerial photograph of the locality of the subject site, showing locations of note
PROJECT NO.:	30043649
PROJECT TITLE	McCrae Landslip Project
CREATED BY:	J.H
DATE:	28/03/2025
